STRUCTURAL BUILDING CONDITION ASSESSMENT

**TIMBER WHARF
32 WORSLEY STREET
MANCHESTER
M15 4NZ**

**DATE OF REPORT ISSUE: March 2024
REFERENCE / ISSUE: HA 10402 / Issue 1**

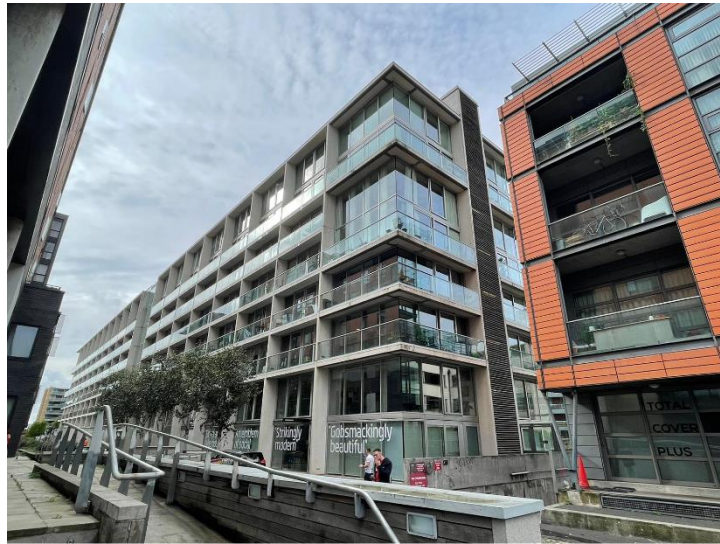
1) Front elevation, Worsley Street

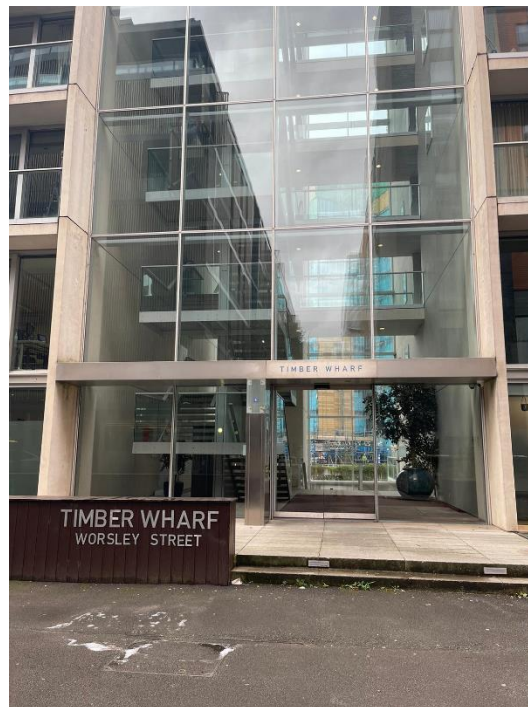
2) Front entrance

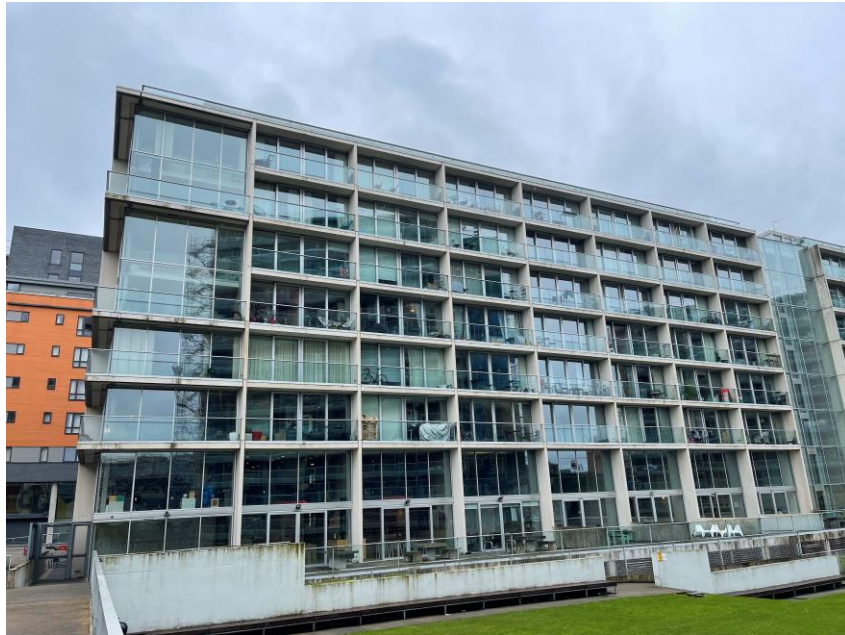
3) Rear elevation

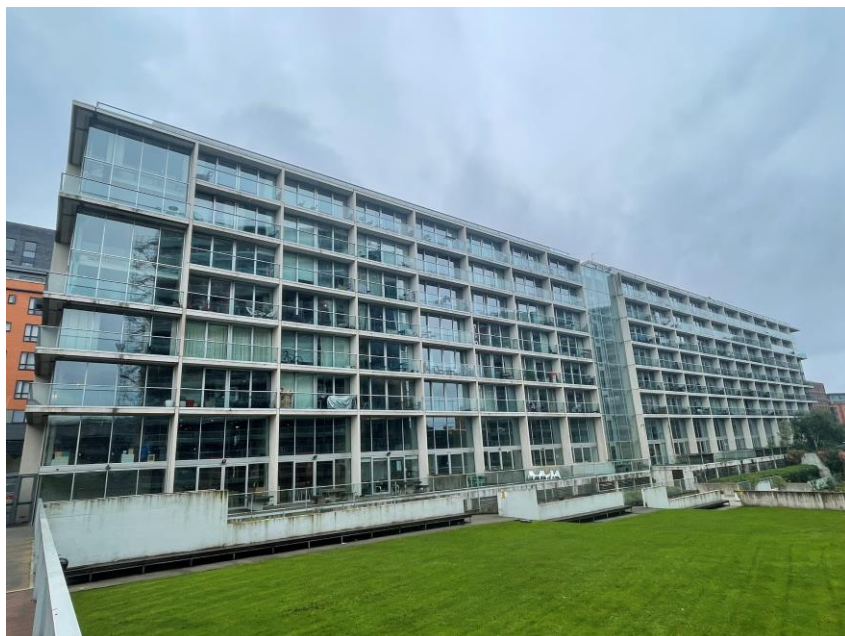
4) Rear elevation and garden

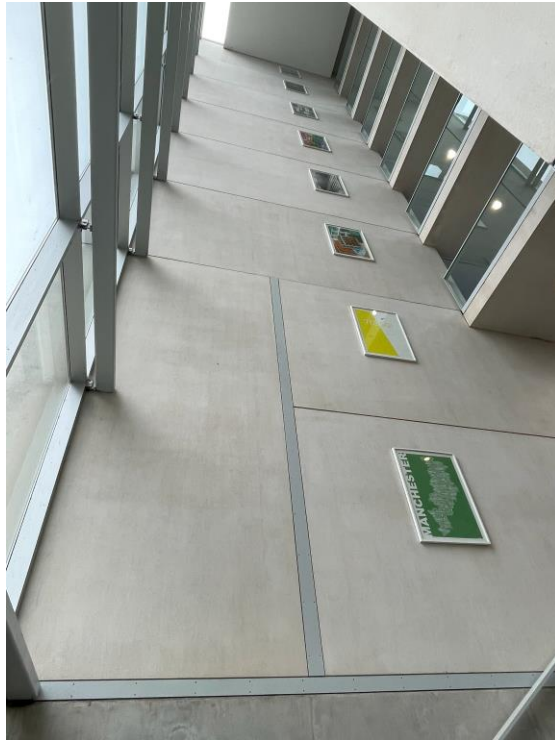
5) Example of internal, common part finishes

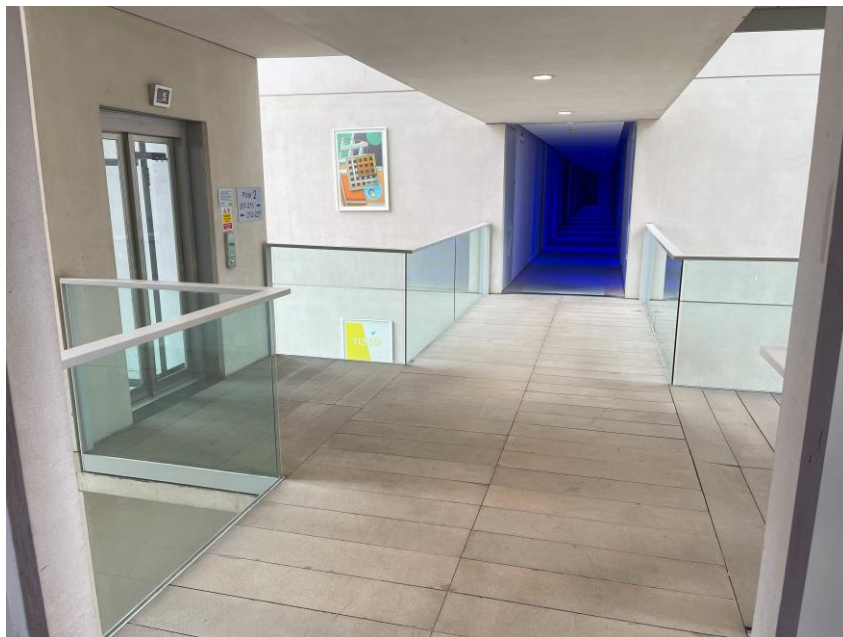
6) Example of internal, common part finishes

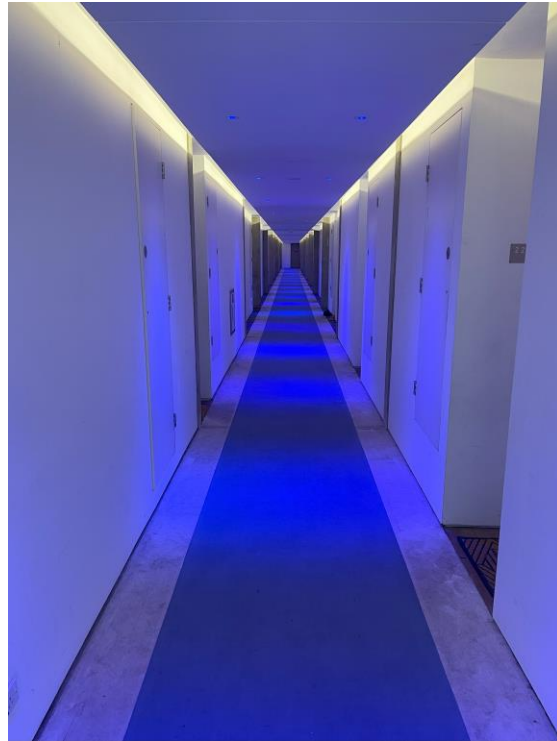
7) Example of internal, common part finishes

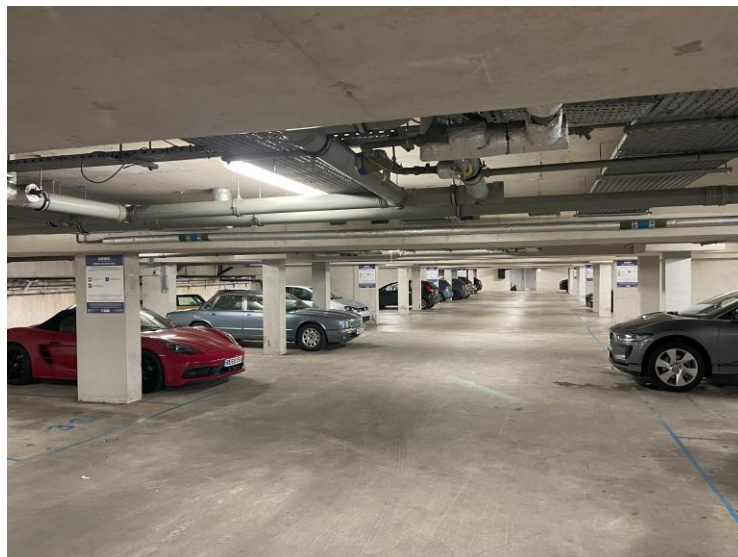
8) Example of basement car park
