Health, Safety & Fire Risk Assessment

Timber Wharf Management Limited

**Timber Wharf
Worsley Street
Castlefield
Manchester
M15 4NZ**

Report reference No: HSF68343/0039/110326/4

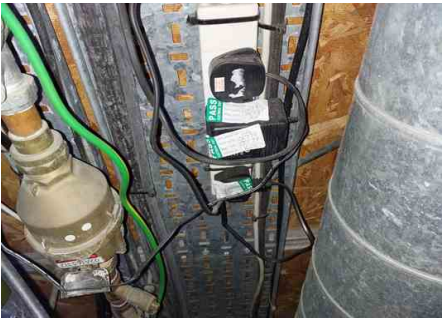
3.4 Action Plan – Fire Risk/Hazards Risk/Hazard			
Site Address	Timber Wharf Worsley Street Castlefield Manchester M15 4NZ	Risk No/Type	E14
		Assessor	Andrew Thompson MIIRSM, MIFSM
		Date	11/03/2026
		Responsible Person/ Body	Timber Wharf Management Limited
Hazard Location			
Risers various			
Hazard Description

Electrical Equipment Testing (Formerly PAT Testing). Individual items of portable electric equipment appear not to have been subject to the EET maintenance system, and some tested but overdue 10.2024			
Potential electric shock and fire hazard.			
People at Risk			
Employees/Contractors/Visitors/Public/Tenants			
Hazard Evaluation			
Severity:	Likelihood/Frequency:	Risk Rating:	Priority:
3	2	6	2
Useful Legislation and Guidance			
Electricity at Work Regulations 1989. HSG 107 & Guidance notes for Maintaining Portable Electrical Equipment, INDG236 Maintaining portable electrical equipment in offices & other low risk environments. IET Code of Practice 5th Edition.

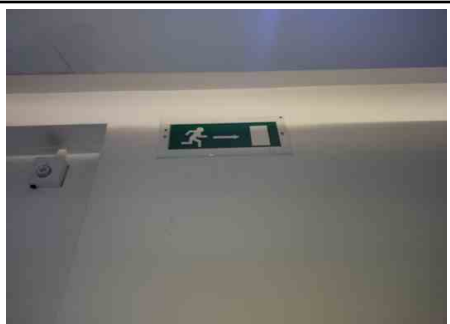
3.4 Action Plan – Fire Risk/Hazards Risk/Hazard				
Site Address	Timber Wharf Worsley Street Castlefield Manchester M15 4NZ	Risk No/Type	EL03	H&S
		Assessor	Andrew Thompson MIIRSM, MIFSM	
		Date	11/03/2026	
		Responsible Person/ Body	Timber Wharf Management Limited	
Hazard Location				
Various units 7th/6th/ 5th/4th/3rd - floor corridors				
Hazard Description

Emergency light inoperative i.e. LED not armed. Potential to cause serious injury and to hinder an evacuation from the building in the event of an emergency situation or failure of the main electrical power supply.				
People at Risk				
Employees/Contractors/Visitors/Public/Tenants				
Hazard Evaluation				
Severity:	Likelihood/Frequency:	Risk Rating:	Priority:	
4	1	4	2	
Useful Legislation and Guidance				
The Regulatory Reform (Fire Safety) Order 2005. Management of Health & Safety at Work Regulations 1999. BS5266-1:2025 Emergency Lighting

Action Required and Further Control Measure				
Employ a qualified, competent and 3rd party accredited contractor to repair / replace the emergency light unit. Ensure that the emergency lighting system is included on the building's maintenance schedule.				
Action Carried Out By:			Action Taken:	
Date:

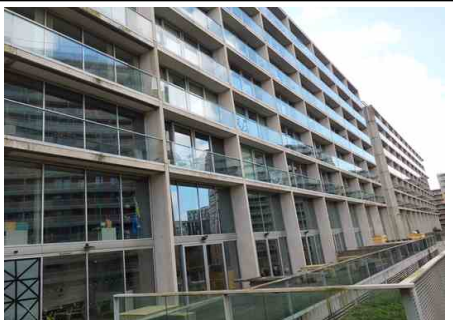
Hazard Description	
<p>Incorrect evacuation strategy determined for building. Buildings current strategy is to stay put, whereas preferred strategy would be simultaneous evacuation.</p> <p>Potential for confusion and panic, which could delay response to an emergency.</p>

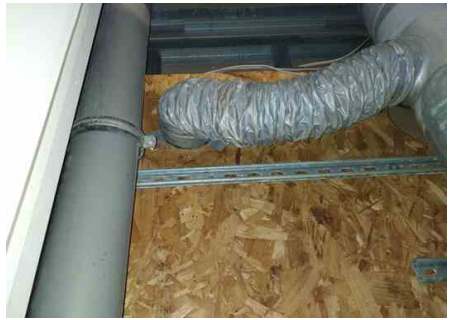
3.4 Action Plan – Fire Risk/Hazards Risk/Hazard			
Site Address	Timber Wharf Worsley Street Castlefield Manchester M15 4NZ	Risk No/Type	FBS03f
		Assessor	Andrew Thompson MIIRSM, MIFSM
		Date	11/03/2026
		Responsible Person/ Body	Timber Wharf Management Limited
Hazard Location			
Various locations risers			
Hazard Description

Whilst a compartmentation survey has been completed, it appears the remedial actions identified within haven't been actioned.			
People at Risk			
Employees/Contractors/Visitors/Public/Tenants			
Hazard Evaluation			
Severity:	Likelihood/Frequency:	Risk Rating:	Priority:
4	2	8	2
Useful Legislation and Guidance			
The Regulatory Reform (Fire Safety) Order 2005 The Association of Specialist Fire Protection Technical Guidance Document TGD 17			
Action Required and Further Control Measure			
Employ a qualified and competent third party contractor to undertake the remedial works identified within the compartmentation survey. Fire stopping works should be subject to regular inspections (no longer than annual) to monitor condition with suitable records maintained.

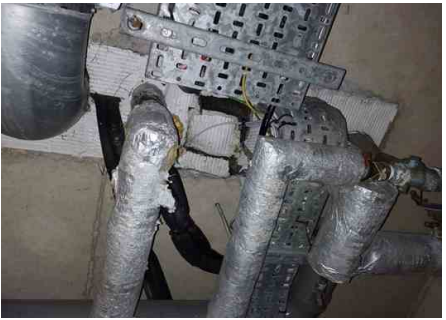
3.4 Action Plan – Fire Risk/Hazards Risk/Hazard				
Site Address	Timber Wharf Worsley Street Castlefield Manchester M15 4NZ	Risk No/Type	FCOMP05	Fire
		Assessor	Andrew Thompson MIIRSM, MIFSM	
		Date	11/03/2026	
		Responsible Person/ Body	Timber Wharf Management Limited	
Hazard Location				
Ceiling basement 1				
Hazard Description

Existing fire stopping damaged or in a state of disrepair. Potential for heat, smoke and/or fire to spread from the point of origin to further parts of the property.				
People at Risk				
Employees/Contractors/Visitors/Public/Tenants				
Hazard Evaluation				
Severity:	Likelihood/Frequency:	Risk Rating:	Priority:	
4	2	8	2	
Useful Legislation and Guidance				
The Regulatory Reform (Fire Safety) Order 2005 The Association of Specialist Fire Protection Technical Guidance Document TGD 17				
Action Required and Further Control Measure				
Employ a qualified and competent third party accredited contractor to remove / repair existing fire stopping materials.

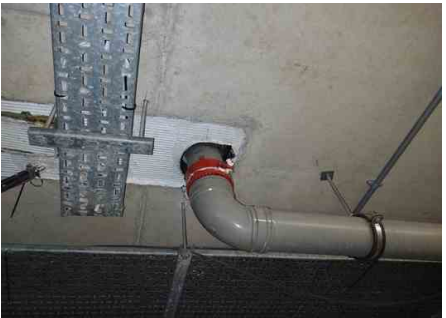
Hazard Description	
The intumescent collar installed around the plastic pipework passing through ceiling has not been installed but dropped so now in the incorrect position. Potential for heat, smoke and/or fire to spread from the point of origin to further parts of the property.

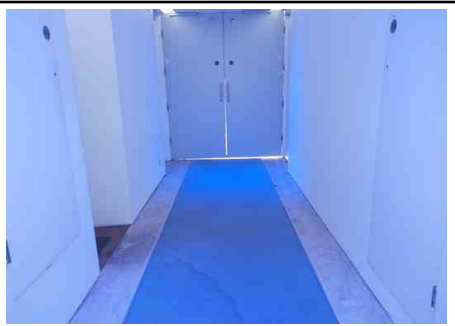
3.4 Action Plan – Fire Risk/Hazards Risk/Hazard				
Site Address	Timber Wharf Worsley Street Castlefield Manchester M15 4NZ	Risk No/Type	FD02c	Fire
		Assessor	Andrew Thompson MIIRSM, MIFSM	
		Date	11/03/2026	
		Responsible Person/ Body	Timber Wharf Management Limited	
Hazard Location				
Corridor doors				
Hazard Description

The gap between the fire door leaf and the frame is excessive, i.e larger than 3mm +/- 1mm.				
Potential for fire and smoke to spread through property.				
People at Risk				
Employees/Contractors/Visitors/Public/Tenants				
Hazard Evaluation				
Severity:	Likelihood/Frequency:	Risk Rating:	Priority:	
2	2	4	2	
Useful Legislation and Guidance				
Regulatory Reform (Fire Safety) Order 2005. BS EN 1634-1:2008+A1:2018				
Action Required and Further Control Measure				
Employ a qualified, competent and 3rd party accredited contractor to carry out the necessary remedial work, to ensure that the gap between the door leaf and the frame is 3mm +/- 1mm.

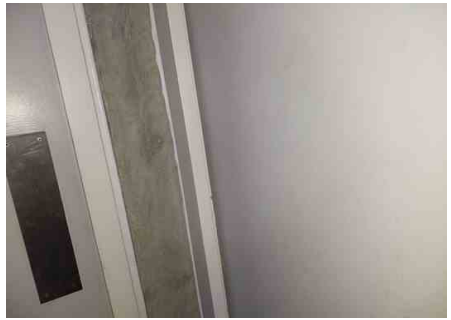
3.4 Action Plan – Fire Risk/Hazards Risk/Hazard				
Site Address	Timber Wharf Worsley Street Castlefield Manchester M15 4NZ	Risk No/Type	FD06c	Fire
		Assessor	Andrew Thompson MIIRSM, MIFSM	
		Date	11/03/2026	
		Responsible Person/ Body	Timber Wharf Management Limited	
Hazard Location				
Throughout property				
Hazard Description				
The communal areas fire door survey, undertaken by IFDI (NW) on 01.03.2026 has highlighted a number of faults which will allow smoke to pass through the door. Potential for smoke to spread throughout the communal areas.

Employ a qualified, competent and 3rd party accredited contractor to undertake the remedial works to the doors as highlighted within the fire door survey with additional surveys implemented on a quarterly basis (refer to non-compliance 4.2.74b)				
Action Carried Out By:			Action Taken:	
Date:

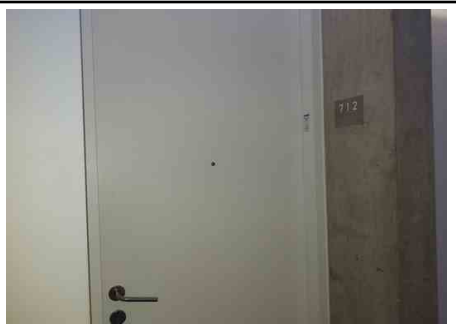
3.4 Action Plan – Fire Risk/Hazards Risk/Hazard				
Site Address	Timber Wharf Worsley Street Castlefield Manchester M15 4NZ	Risk No/Type	FD06d	Fire
		Assessor	Andrew Thompson MIIRSM, MIFSM	
		Date	11/03/2026	
		Responsible Person/ Body	Timber Wharf Management Limited	
Hazard Location				
Throughout property				
Hazard Description

The residential tenants entry door / fire door survey, undertaken by IFDI (NW) on 01.03.2026, has highlighted a number of faults which will allow smoke to pass through the door. Potential for smoke to spread throughout the communal areas.				
People at Risk				
Employees/Contractors/Visitors/Public/Tenants				
Hazard Evaluation				
Severity:	Likelihood/Frequency:	Risk Rating:	Priority:	
4	2	8	2	
Useful Legislation and Guidance				
The Regulatory Reform (Fire Safety) Order 2005. The Fire safety (England) Regulations 2022. BS 476, BS EN 1634.				
Action Required and Further Control Measure

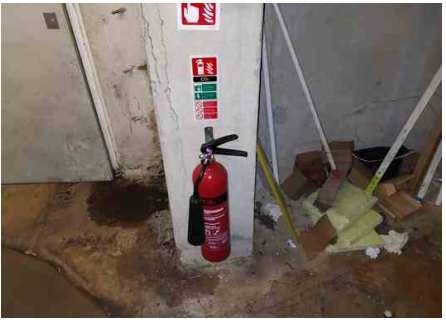
3.4 Action Plan – Fire Risk/Hazards Risk/Hazard				
Site Address	Timber Wharf Worsley Street Castlefield Manchester M15 4NZ	Risk No/Type	FEX04	Fire
		Assessor	Andrew Thompson MIIRSM, MIFSM	
		Date	11/03/2026	
		Responsible Person/ Body	Timber Wharf Management Limited	
Hazard Location				
Electric meter room B2				
Hazard Description

Fire extinguishers are overdue for service. Extinguishers last has no service label				
Potential reduction in firefighting capability.				
People at Risk				
Employees/Contractors/Visitors/Public/Tenants				
Hazard Evaluation				
Severity:	Likelihood/Frequency:	Risk Rating:	Priority:	
4	1	4	2	
Useful Legislation and Guidance				
Regulatory Reform (Fire Safety) Order 2005. Management of Health & Safety at Work Regulations 1999. Workplace (Health, Safety & Welfare) Regulations 1992. B.S. 5306 -8:2017.				
Action Required and Further Control Measure				
Employ a qualified, competent and 3rd party accredited contractor to service / replace the extinguishers.

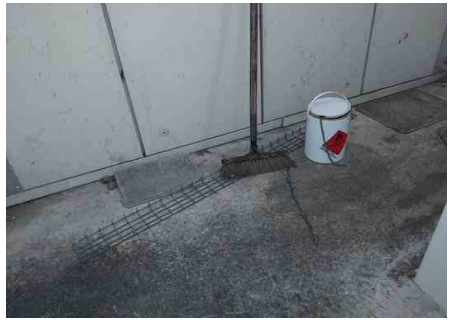
3.4 Action Plan – Fire Risk/Hazards Risk/Hazard			
Site Address	Timber Wharf Worsley Street Castlefield Manchester M15 4NZ	Risk No/Type	FLAM01
		Assessor	Andrew Thompson MIIRSM, MIFSM
		Date	11/03/2026
		Responsible Person/ Body	Timber Wharf Management Limited
Hazard Location			
Stairwell			
Hazard Description

Flammable items incorrectly stored. Potential fire/explosion risk.			
People at Risk			
Disabled/visitors/contractors/tenants on site			
Hazard Evaluation			
Severity:	Likelihood/Frequency:	Risk Rating:	Priority:
3	2	6	2
Useful Legislation and Guidance			
The Regulatory Reform (Fire Safety) Order 2005.			
Action Required and Further Control Measure			
Remove flammable items and either store in a designated storage area or dispose of in the correct manner. Inform all tenants, employees & contractors (in writing) that communal areas (including plant & service areas) should not be used for the storage of flammable items.

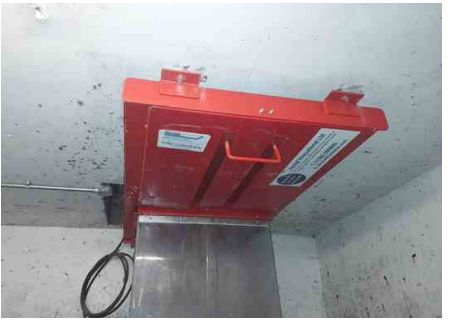
Hazard Description	
No evidence observed relating to testing and inspection of the cause and effect of fire alarm tests. Potential reduction in fire safety provisions.

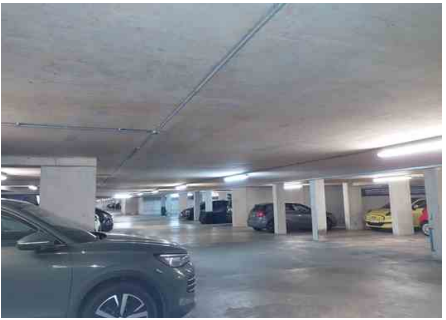
3.4 Action Plan – Fire Risk/Hazards Risk/Hazard			
Site Address	Timber Wharf Worsley Street Castlefield Manchester M15 4NZ	Risk No/Type	FSV03
		Assessor	Andrew Thompson MIIRSM, MIFSM
		Date	11/03/2026
		Responsible Person/ Body	Timber Wharf Management Limited
Hazard Location			
Car park area			
Hazard Description

No smoke ventilation system is provided within the car park area, build up of smoke in this area.			
People at Risk			
Employees/Contractors/Visitors/Public/Tenants			
Hazard Evaluation			
Severity:	Likelihood/Frequency:	Risk Rating:	Priority:
4	2	8	2
Useful Legislation and Guidance			
The Regulatory Reform (Fire Safety) Order 2005. The Management of Health & Safety at Work Regulations 1999.			
Action Required and Further Control Measure			
It is recommended that the Responsible Person, review the fire strategy as this is covered in the report. Get the fire engineer or smoke control engineer to determine what is required.

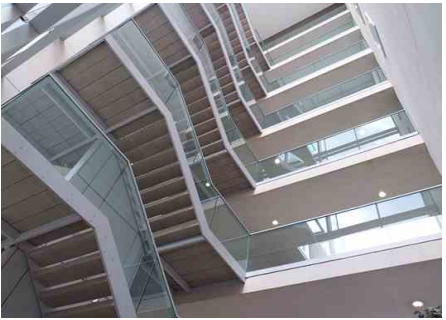
3.4 Action Plan – Fire Risk/Hazards Risk/Hazard			
Site Address	Timber Wharf Worsley Street Castlefield Manchester M15 4NZ	Risk No/Type	FSV03
		Assessor	Andrew Thompson MIIRSM, MIFSM
		Date	11/03/2026
		Responsible Person/ Body	Timber Wharf Management Limited
Hazard Location			
Atrium and corridors			
Hazard Description

No automatic fire detection is provided within the atrium or communal corridor areas.			
People at Risk			
Disabled/visitors/contractors/tenants on site			
Hazard Evaluation			
Severity:	Likelihood/Frequency:	Risk Rating:	Priority:
4	2	8	2
Useful Legislation and Guidance			
The Regulatory Reform (Fire Safety) Order 2005. The Management of Health & Safety at Work Regulations 1999.			
Action Required and Further Control Measure			
It is recommended that the Responsible Person, review the fire strategy as this is covered in the report. Get the fire engineer or smoke control engineer to determine what is required.

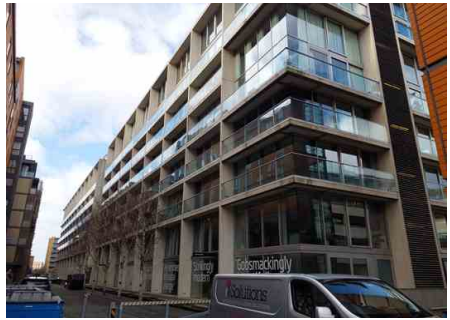
3.4 Action Plan – Fire Risk/Hazards Risk/Hazard				
Site Address	Timber Wharf Worsley Street Castlefield Manchester M15 4NZ	Risk No/Type	MMRC01	H&S
		Assessor	Andrew Thompson MIIRSM, MIFSM	
		Date	11/03/2026	
		Responsible Person/ Body	Timber Wharf Management Limited	
Hazard Location				
Throughout property				
Hazard Description				
Resident engagement. Pending the remediation of compartmentation, there is an increased risk of internal fire spread.

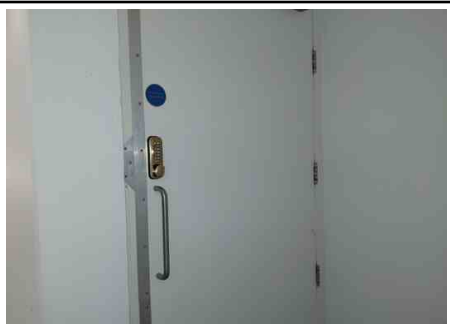
3.4 Action Plan – Fire Risk/Hazards Risk/Hazard				
Site Address	Timber Wharf Worsley Street Castlefield Manchester M15 4NZ	Risk No/Type	No Access	H&S
		Assessor	Andrew Thompson MIIRSM, MIFSM	
		Date	11/03/2026	
		Responsible Person/ Body	Timber Wharf Management Limited	
Hazard Location				
Basement 1 store cupboard				
Hazard Description

The attending advisor was unable to gain access to this area, code would not open door				
Potential for hazards to exist undetected, remain unmanaged and subsequently, cause injury and/or present a fire hazard.				
People at Risk				
Employees/Contractors/Visitors/Public/Tenants				
Hazard Evaluation				
Severity:	Likelihood/Frequency:	Risk Rating:	Priority:	
4	2	8	2	
Useful Legislation and Guidance				
Health & Safety at Work Act 1974. Regulatory Reform (Fire Safety) Order 2005.				
Action Required and Further Control Measure				
Ensure that a competent person gains access to this area in order to ascertain if there are any hazards present.

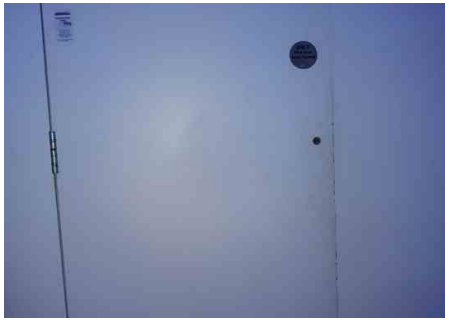
3.4 Action Plan – Fire Risk/Hazards Risk/Hazard				
Site Address	Timber Wharf Worsley Street Castlefield Manchester M15 4NZ	Risk No/Type	No Access	H&S
		Assessor	Andrew Thompson MIIRSM, MIFSM	
		Date	11/03/2026	
		Responsible Person/ Body	Timber Wharf Management Limited	
Hazard Location				
Some risers				
Hazard Description

The attending advisor was unable to gain access to this area, unable to access some risers as key doesnt engage and hard to open				
Potential for hazards to exist undetected, remain unmanaged and subsequently, cause injury and/or present a fire hazard.				
People at Risk				
Employees/Contractors/Visitors/Public/Tenants				
Hazard Evaluation				
Severity:	Likelihood/Frequency:	Risk Rating:	Priority:	
4	2	8	2	
Useful Legislation and Guidance				
Health & Safety at Work Act 1974. Regulatory Reform (Fire Safety) Order 2005.				
Action Required and Further Control Measure				
Ensure that a competent person gains access to this area in order to ascertain if there are any hazards present.

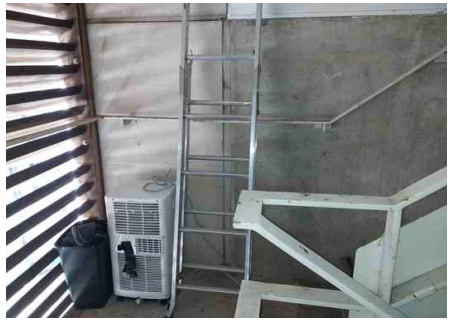
Hazard Description	
Abandoned/orphaned ladder. Unable to determine who owns the ladder, and as such, the ladder has not been maintained and may not be safe for use.

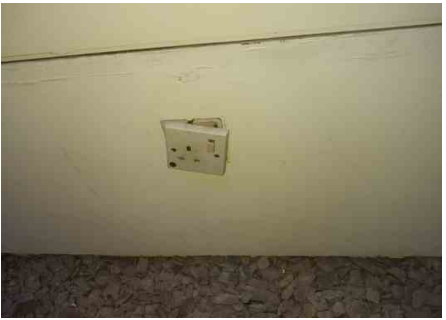
3.5 Action Plan – Fire Risk/Hazards Risk/Hazard				
Site Address	Timber Wharf Worsley Street Castlefield Manchester M15 4NZ	Risk No/Type	E06	H&S
		Assessor	Andrew Thompson MIIRSM, MIFSM	
		Date	11/03/2026	
		Responsible Person/ Body	Timber Wharf Management Limited	
Hazard Location				
Plug loose 4th floor near flat 414				
Hazard Description

Plug loose so exposing connections Potential electric shock.				
People at Risk				
Employees/Contractors/Visitors/Public/Tenants				
Hazard Evaluation				
Severity:	Likelihood/Frequency:	Risk Rating:	Priority:	
2	1	2	3	
Useful Legislation and Guidance				
Management of Health & Safety at Work Regulations 1999. Electricity at Work Regulations 1989. IEE Regulations 18th Edition.				
Action Required and Further Control Measure				
Employ a qualified, competent and 3rd party accredited contractor to confirm if the exposed electrical wiring and connections are "live" & to isolate, reconnect or disconnect from the electrical circuit as required.

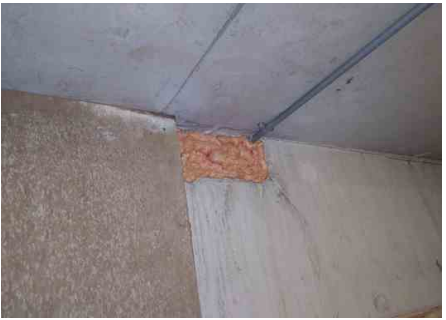
3.5 Action Plan – Fire Risk/Hazards Risk/Hazard			
Site Address	Timber Wharf Worsley Street Castlefield Manchester M15 4NZ	Risk No/Type	FBS04
		Assessor	Andrew Thompson MIIRSM, MIFSM
		Date	11/03/2026
		Responsible Person/ Body	Timber Wharf Management Limited
Hazard Location			
Meter room B2 and risers			
Hazard Description

Excessive amount of intumescent foam has been used to fire stop gaps. Foam has been allowed to expand and hasn't been cut back so the size of the gap can't be determined. Foam should only be used for gaps stipulated in the manufacturer data sheet.			
Potential for fire and smoke to spread through the property			
People at Risk			
Employees/Contractors/Visitors/Public/Tenants			
Hazard Evaluation			
Severity:	Likelihood/Frequency:	Risk Rating:	Priority:
3	1	3	3
Useful Legislation and Guidance			
Regulatory Reform (Fire Safety) Order 2005.			
Action Required and Further Control Measure

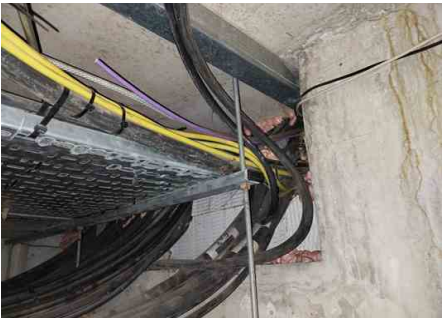
3.5 Action Plan – Fire Risk/Hazards Risk/Hazard				
Site Address	Timber Wharf Worsley Street Castlefield Manchester M15 4NZ	Risk No/Type	FBS04a	Fire
		Assessor	Andrew Thompson MIIRSM, MIFSM	
		Date	11/03/2026	
		Responsible Person/ Body	Timber Wharf Management Limited	
Hazard Location				
Meter room B2 and car park ceiling				
Hazard Description

Use of expanding foam on plaster board. Expanding foam (fire stopping foam) is not rated or tested for use on drywall and is only to be used on masonry / concrete walls for small penetrations or linear gap sealing e.g around a fire door frame. Increases the likelihood of fire / smoke spreading through the property.				
People at Risk				
Employees/Contractors/Visitors/Public/Tenants				
Hazard Evaluation				
Severity:	Likelihood/Frequency:	Risk Rating:	Priority:	
1	3	3	3	
Useful Legislation and Guidance				
The Regulatory Reform (Fire Safety) Order 2005

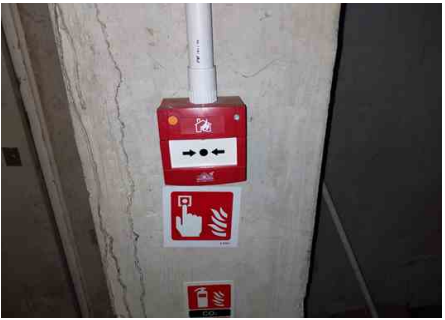
Manual call points not numbered.			
Potential for call points not being tested in rotation			
People at Risk			
Employees/Contractors/Visitors/Public/Tenants			
Hazard Evaluation			
Severity:	Likelihood/Frequency:	Risk Rating:	Priority:
1	1	1	3
Useful Legislation and Guidance			
Regulatory Reform (Fire Safety) Order 2005. Management of Health & Safety at Work Regulations 1999. BS 5839-6:2019.			
Action Required and Further Control Measure			
Employ a competent person to number the manual call points.			
A different manual call point should be used at the time of every weekly test, so that all manual call points in the building are tested in rotation over a prolonged period.

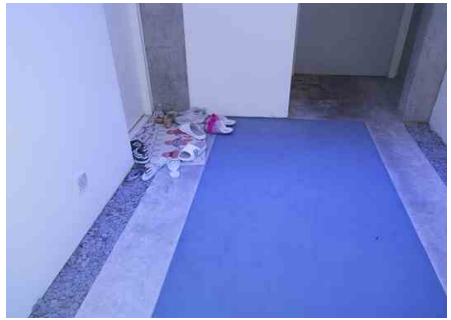
Storage on escape route.			
Although not a significant hazard at the time, if storage is allowed to accumulate, it could result in blocked escape routes.			
Potential to hinder evacuation of building in the event of an emergency.			
People at Risk			
Employees/Contractors/Visitors/Public/Tenants			
Hazard Evaluation			
Severity:	Likelihood/Frequency:	Risk Rating:	Priority:
1	1	1	3
Useful Legislation and Guidance			
Regulatory Reform (Fire Safety) Order 2005.			
Action Required and Further Control Measure			
Employ a competent person to remove the items stored on the escape route.

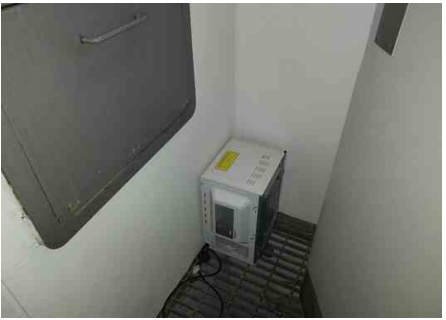
Items are being stored in bin chute/riser area.			
Potential obstruction for emergency services, leading to a delay in firefighting operations.			
People at Risk			
Employees/Contractors/Visitors/Public/Tenants			
Hazard Evaluation			
Severity:	Likelihood/Frequency:	Risk Rating:	Priority:
1	1	1	3
Useful Legislation and Guidance			
Regulatory Reform (Fire Safety) Order 2005. Management of Health & Safety at Work Regulations 1999. BS 5041-1987. BS 9990-2015			
Action Required and Further Control Measure			
Remove stored items from bin chute area. Inform occupants that these cupboards are not to be used for storage.

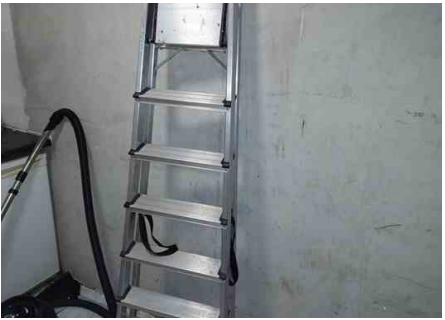
Incorrect storage of ladder. Potential fall / falling object hazards.			
People at Risk			
Employees/Contractors/Visitors/Public/Tenants			
Hazard Evaluation			
Severity:	Likelihood/Frequency:	Risk Rating:	Priority:
1	1	1	3
Useful Legislation and Guidance			
Health and Safety at Work Act 1974. Management of Health & Safety at Work Regulations 1999. The Work at Height Regulations 2005.			
Action Required and Further Control Measure			
Ladders should be stored and secured horizontally on their stiles on racks / brackets. They are to be suitably supported to prevent sagging and damage. If ladders are to be stored vertically they must be adequately secured.

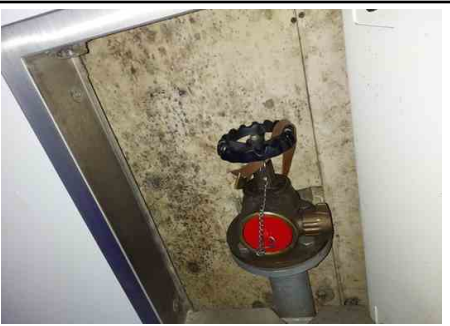
Evidence of Water Ingress/Leak, evidence of black mould. Potential for localised flooding, damage to building structure, and health issues associated with damp conditions.				
People at Risk				
Employees/Contractors/Visitors/Public/Tenants				
Hazard Evaluation				
Severity:	Likelihood/Frequency:	Risk Rating:	Priority:	
1	1	1	3	
Useful Legislation and Guidance				
Health & Safety at Work Act 1974. Management of Health & Safety at Work Regulations 1999. Workplace (Health, Safety & Welfare) Regulations 1992,				
Action Required and Further Control Measure				
Employ a qualified, competent and 3rd party accredited contractor to investigate the source of the leak and carry out any necessary repairs. Ensure area is inspected regularly as part of the building maintenance schedule to check for any recurrence.

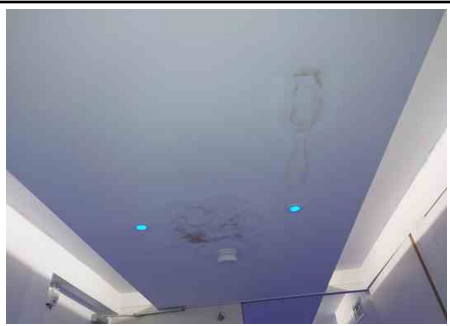
Evidence of Water Ingress/Leak. Potential for localised flooding, damage to building structure, and health issues associated with damp conditions.				
People at Risk				
Employees/Contractors/Visitors/Public/Tenants				
Hazard Evaluation				
Severity:	Likelihood/Frequency:	Risk Rating:	Priority:	
1	1	1	3	
Useful Legislation and Guidance				
Health & Safety at Work Act 1974. Management of Health & Safety at Work Regulations 1999.Workplace (Health, Safety & Welfare) Regulations 1992,				
Action Required and Further Control Measure				
Employ a qualified, competent and 3rd party accredited contractor to investigate the source of the leak and carry out any necessary repairs. Ensure area is inspected regularly as part of the building maintenance schedule to check for any recurrence.
