**Burton Place Apartments**

**252780-CCS-S1-XX-RP-S-0002**

**BWP Consultant**

## Structural Investigation Report

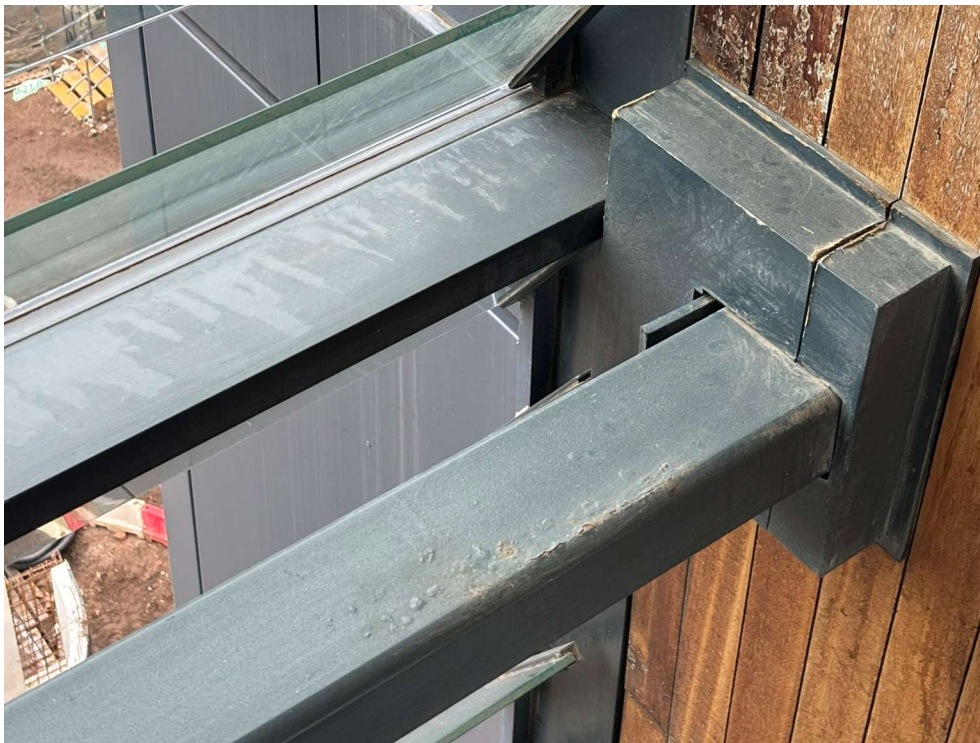
Within the shared corridor areas between apartments, exposed steel beams along the southern elevation at Gridline C were observed to exhibit minor signs of corrosion. The corrosion visible at the time of inspection appeared to be limited to surface corrosion only and is not currently considered to be of structural concern. Monitoring of the steelwork is recommended, along with the replacement of the protective coating system, if the condition worsens and deterioration is considered significant.

*Figure 20 - Typical photograph of surface corrosion with corridors*

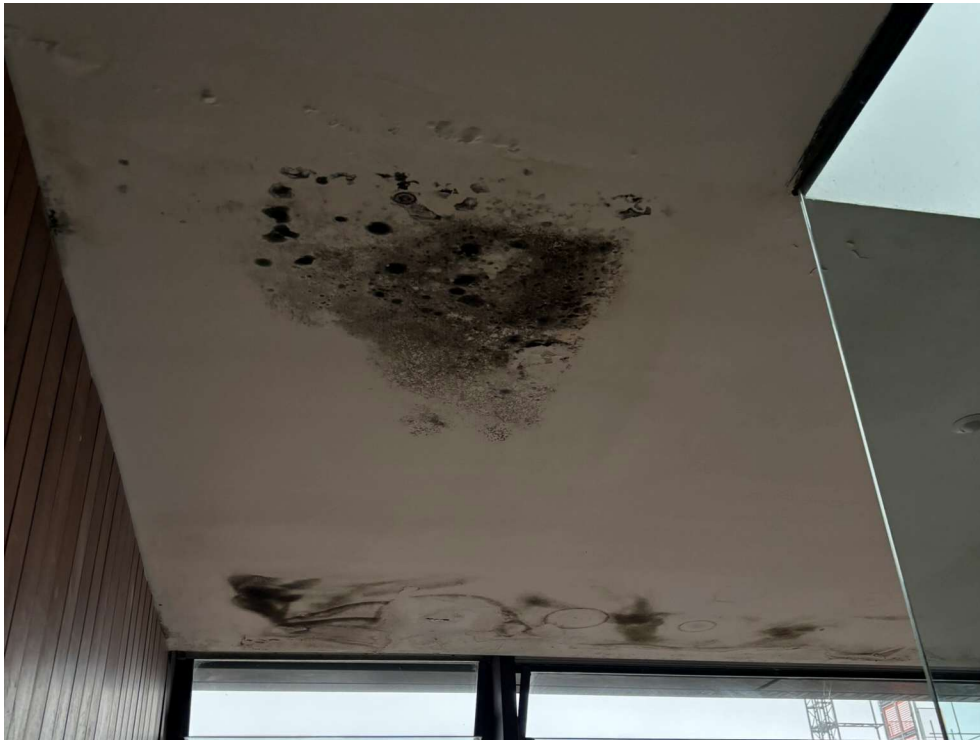
In the corridor between the apartments at Level 7, evidence of historic water ingress was observed, including areas of mould growth. At the time of the survey, no active water penetration was noted. As this was a visual structural survey only, it was not possible to determine whether the previous water

*Figure 21 - Typical photograph showing evidence of water ingress, mould to soffit of roof construction*

ingress has resulted in deterioration of any concealed structural members. It is recommended that finishes be locally removed in the affected areas and that a targeted structural inspection be undertaken.

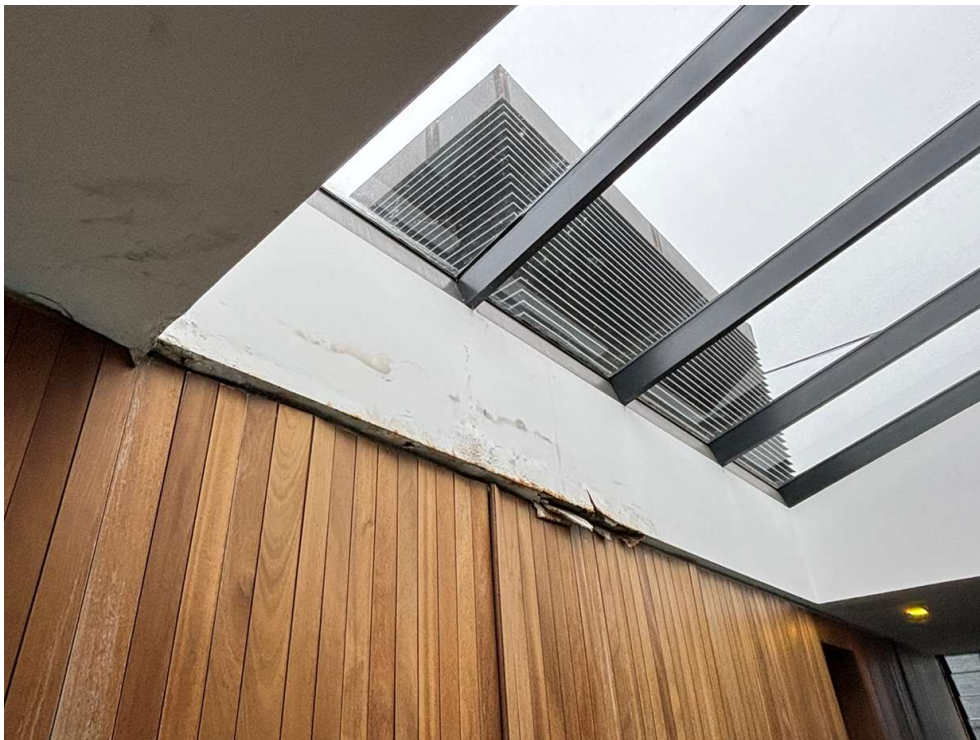
*Figure 22 - Typical photograph showing evidence of water ingress, risk of corrosion to steelwork*

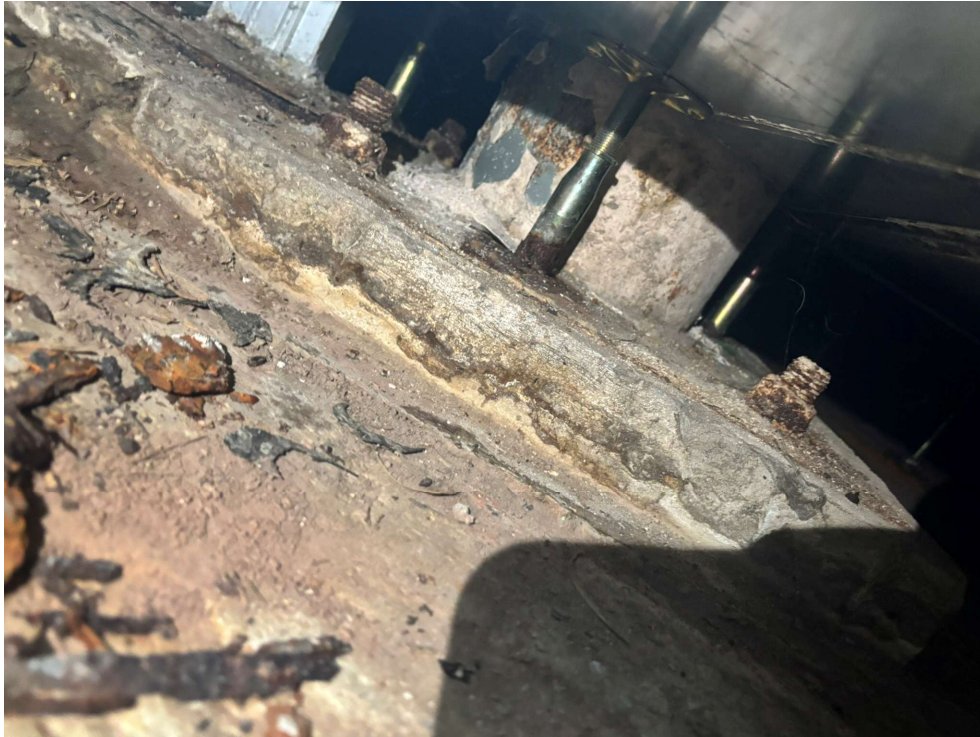
At Ground Floor, within Unit 2 (the easternmost unit at the north-east corner of the building), water ingress was identified. This has resulted in minor visible surface corrosion to the leg supports of the raised access floor system. The full extent of the corrosion is unknown due to floor finishes concealing the structure; however, corrosion was observed centrally within the unit. In addition, corrosion was noted to the column base plate just off Gridline 13H. It is unclear whether this is a localised issue or more widespread. Further intrusive investigations are recommended to determine the extent of deterioration and any required remedial works.

*Figure 23 - Photograph of corrosion to baseplate just off Gridline 13H*

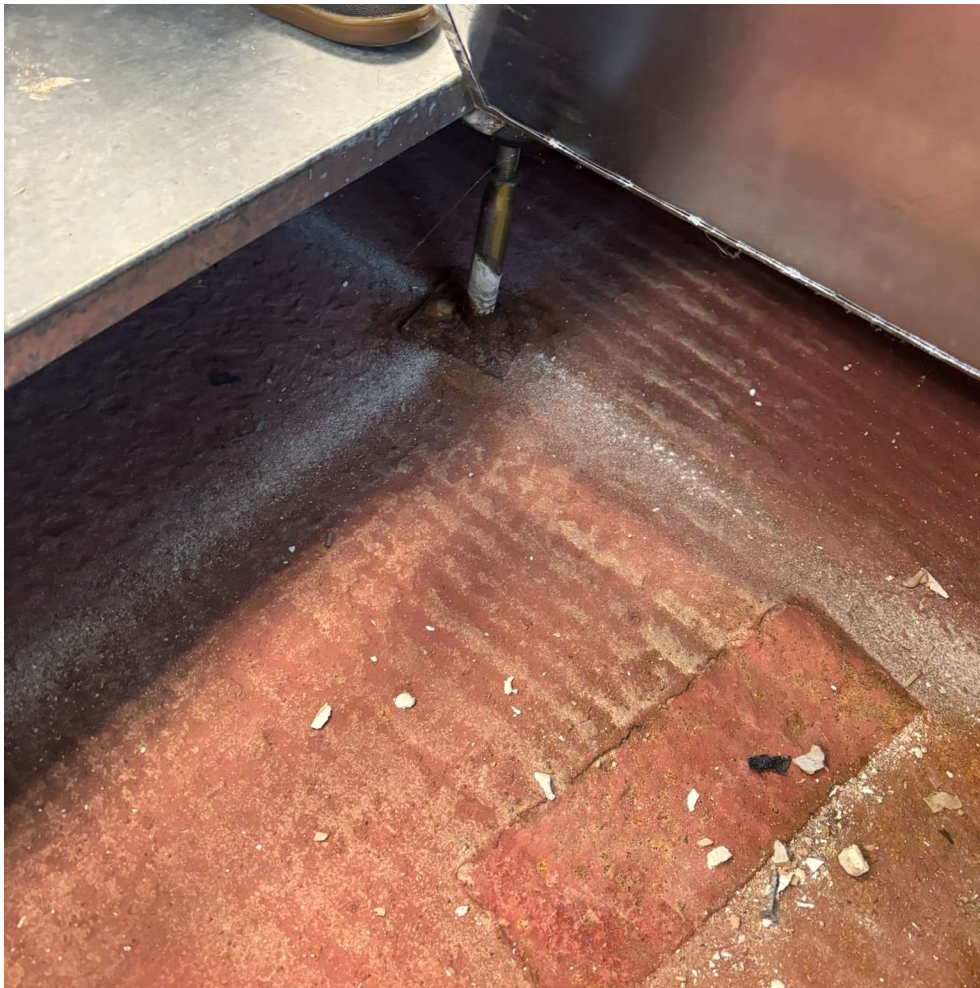
*Figure 24 - Typical Photograph of corrosion to raised access floor support*

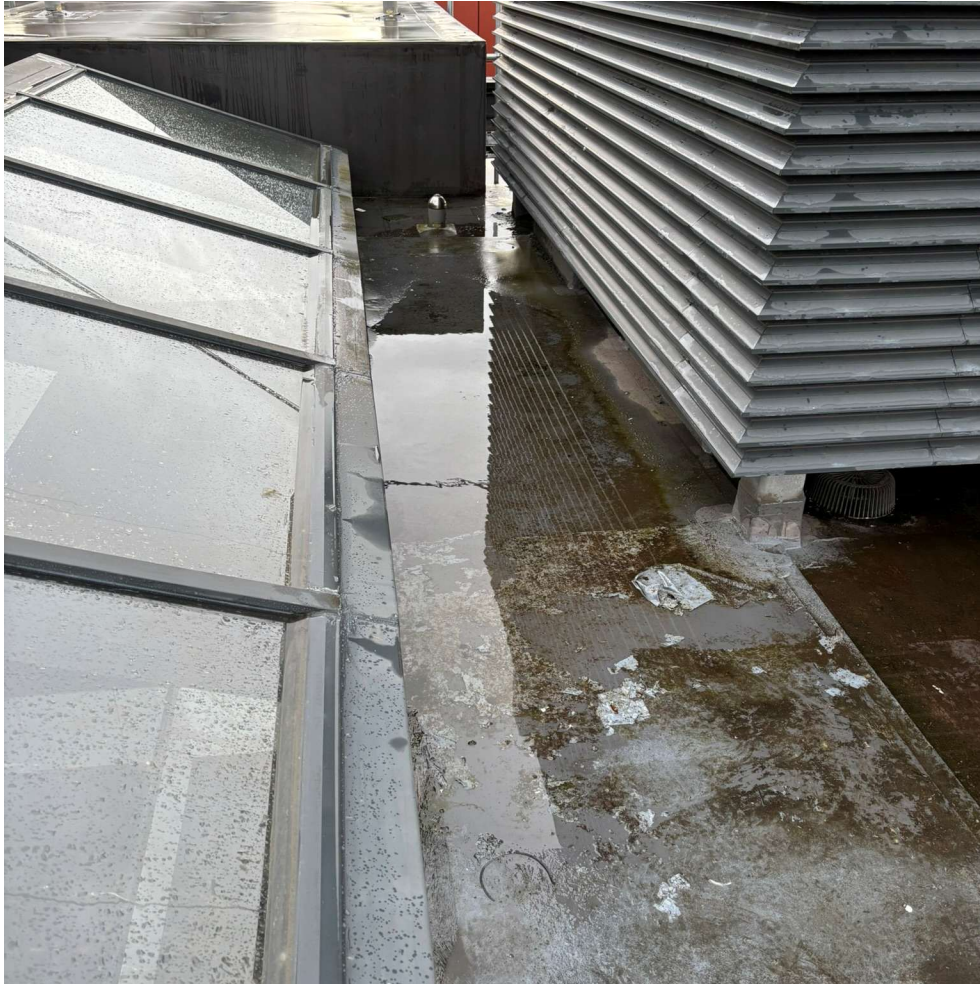
Areas of ponding water were observed. This is likely due to partially blocked downpipes or gutters; however, inadequate falls to the roof finish cannot be ruled out.

As outlined in Section 6.1, water ingress and mould have been identified. It is currently unknown whether these are historic occurrences or indicative of ongoing moisture penetration. These areas should therefore be monitored to determine whether active water ingress is present and to assess whether defects may be localised to the roof waterproofing system.

*Figure 25 - Typical photograph of pooling*

It should be noted that rainfall had occurred prior to the inspection, and therefore, it was not possible to determine whether ponding is persistent or temporary. It is recommended that all gutters and downpipes be cleaned and cleared, followed by monitoring of the roof during subsequent rainfall events to determine whether ponding remains. If pooling persists, further investigation into the adequacy of the roof falls should be undertaken.

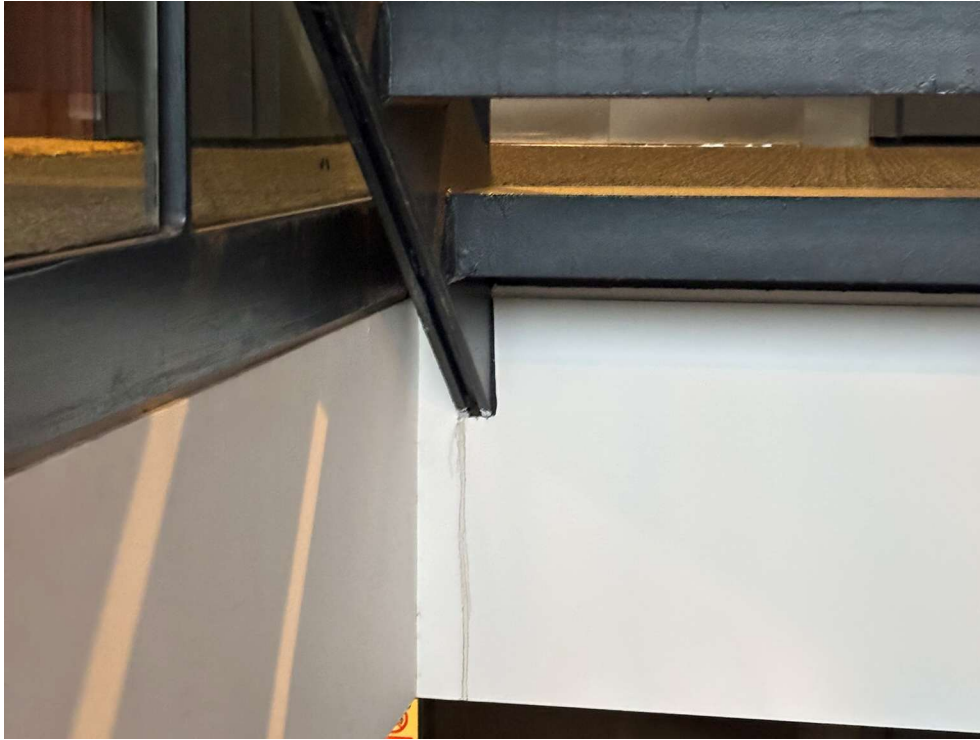
The lightweight steel staircases are in generally good condition. However, minor water staining was noted in isolated areas. While this is not currently considered structurally significant, monitoring of the area is recommended.

*Figure 26 – Minor staining to the plasterboard from run-off from the steel staircase.*

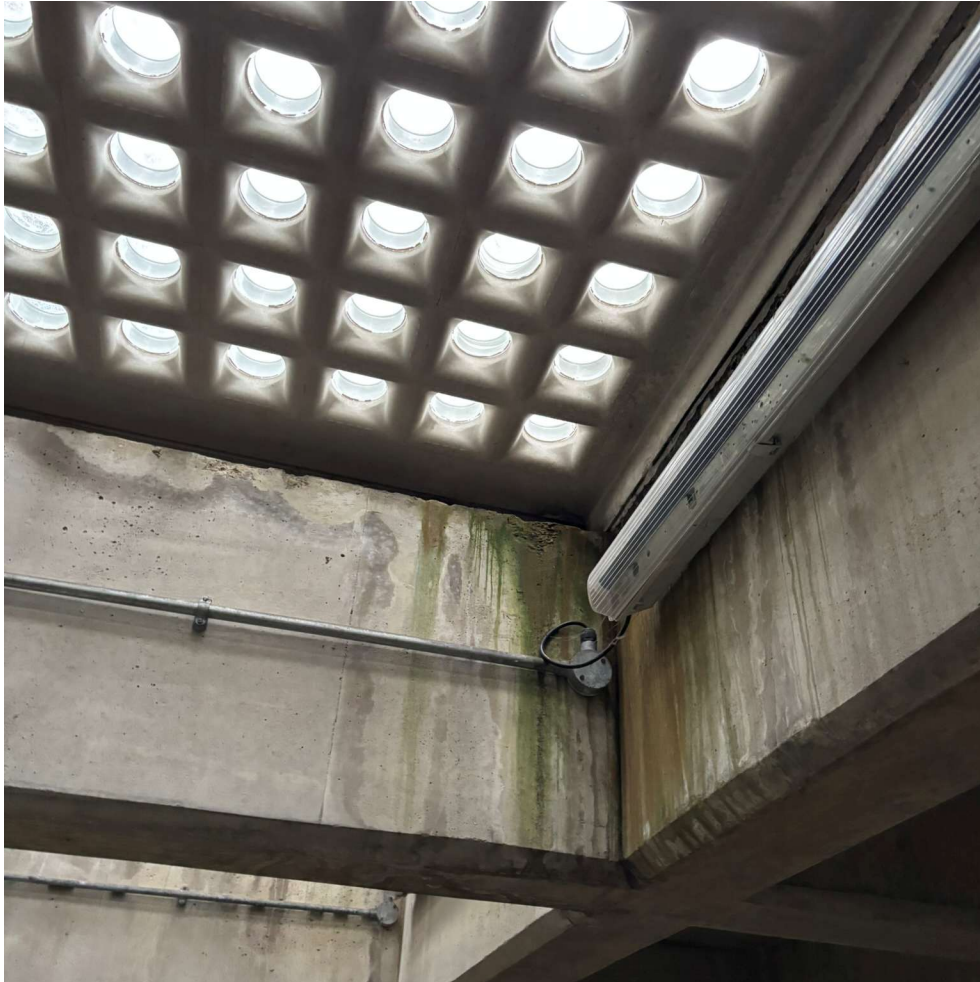
Within the basement, water ingress was noted in areas external to the main building footprint, where the in-situ concrete deck construction transitions to a floor construction that allows natural light into the space.

*Figure 27 - Typical photograph of water ingress at joints of basement lightwell*

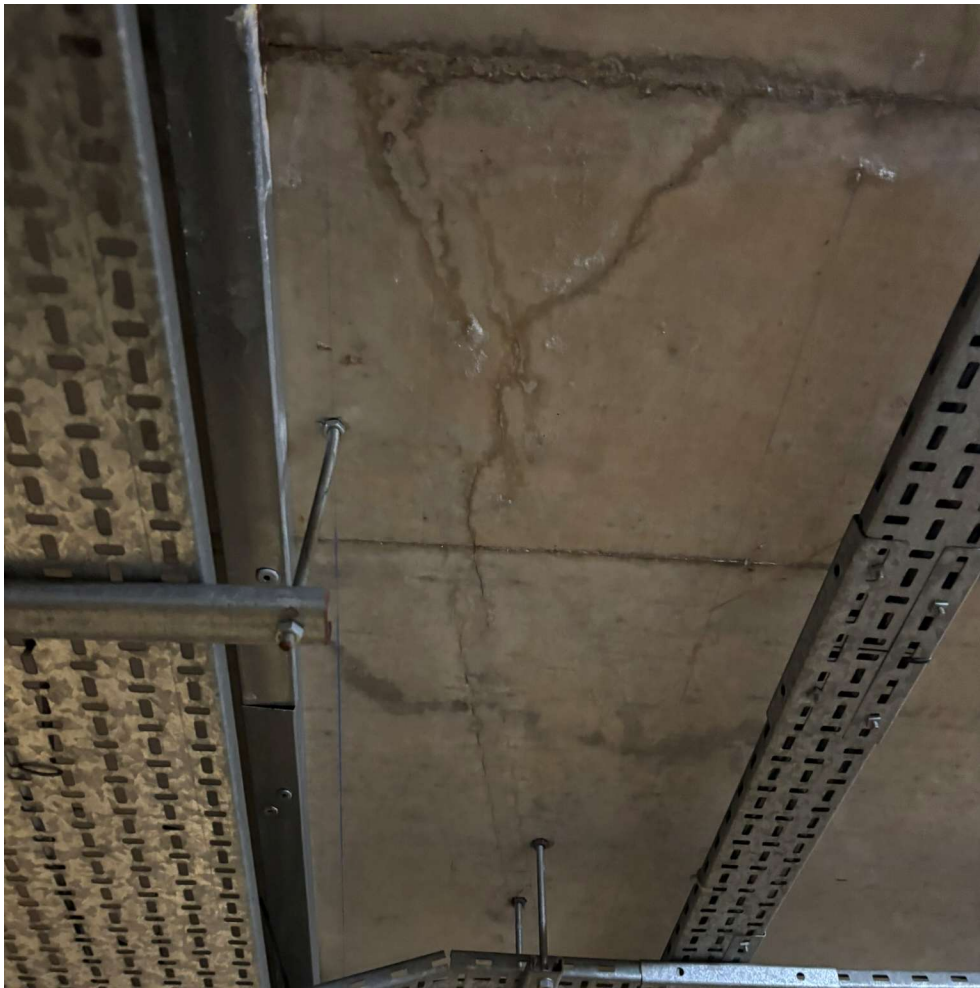
Hairline cracking was observed to the soffit of the in-situ reinforced concrete floor plate. The cracking is fine in nature and is considered consistent with shrinkage or curing-related cracking. At the time of inspection, it is not considered to be of structural concern; however, the affected areas should be monitored to ensure that no progressive widening or associated movement occurs.

*Figure 28 - Typical photograph of cracking to the basement soffit*

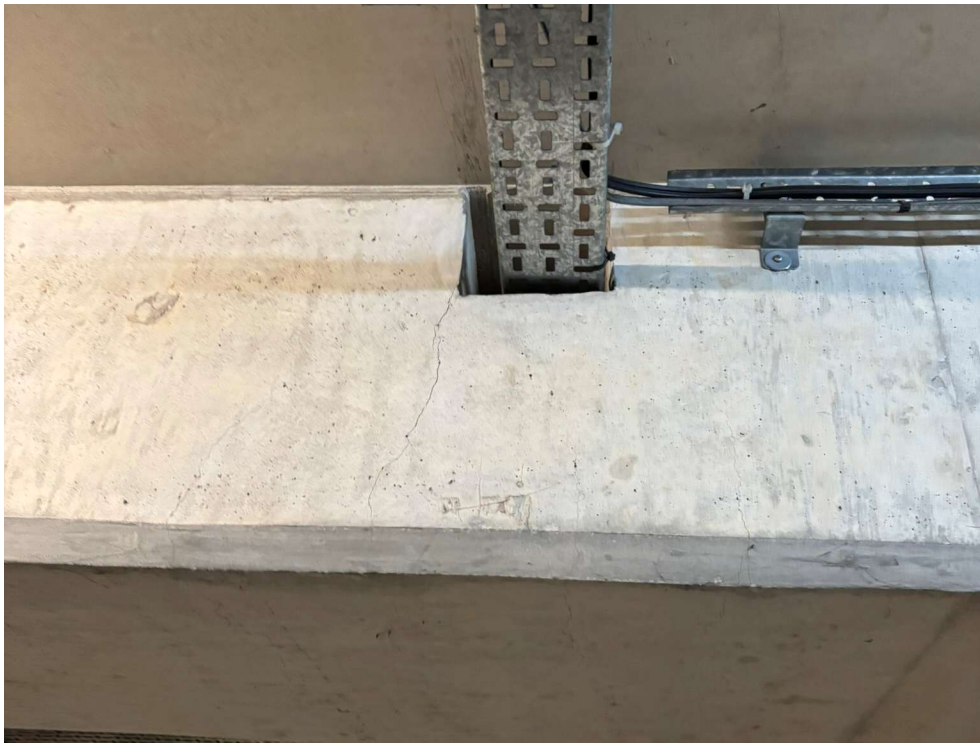
Additional hairline cracking was observed in concrete beams where service penetrations have been formed. Given the fine nature of the cracking, this is also likely attributable to shrinkage or curing effects. These areas should similarly be monitored as a precautionary measure.

*Figure 29 - Typical Photograph of Cracking Local to Service Opening in Basement Beams*

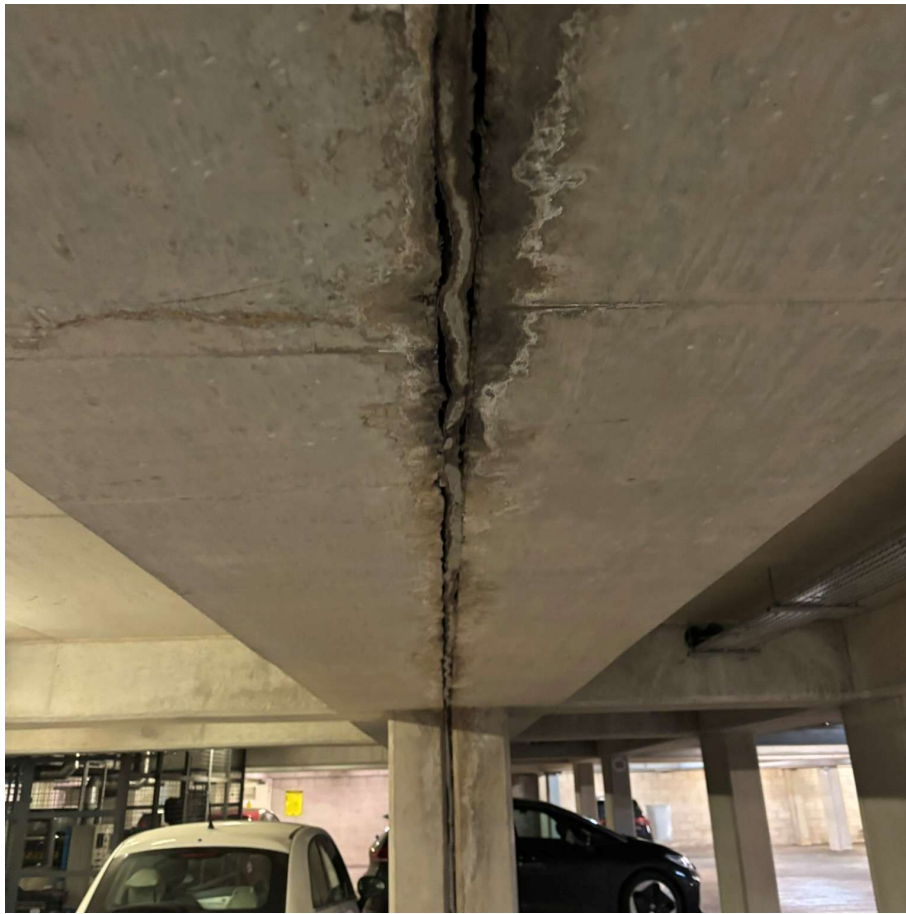
Between Burton Place and the Moho Building, a movement joint is present. Signs of joint failure were observed, including voids between the two structures that are permitting water ingress. It is recommended that the joint be raked out and properly reinstated to prevent further moisture penetration.

*Figure 30 - Typical Photograph of Failed Movement Joint Plus Water Ingress*

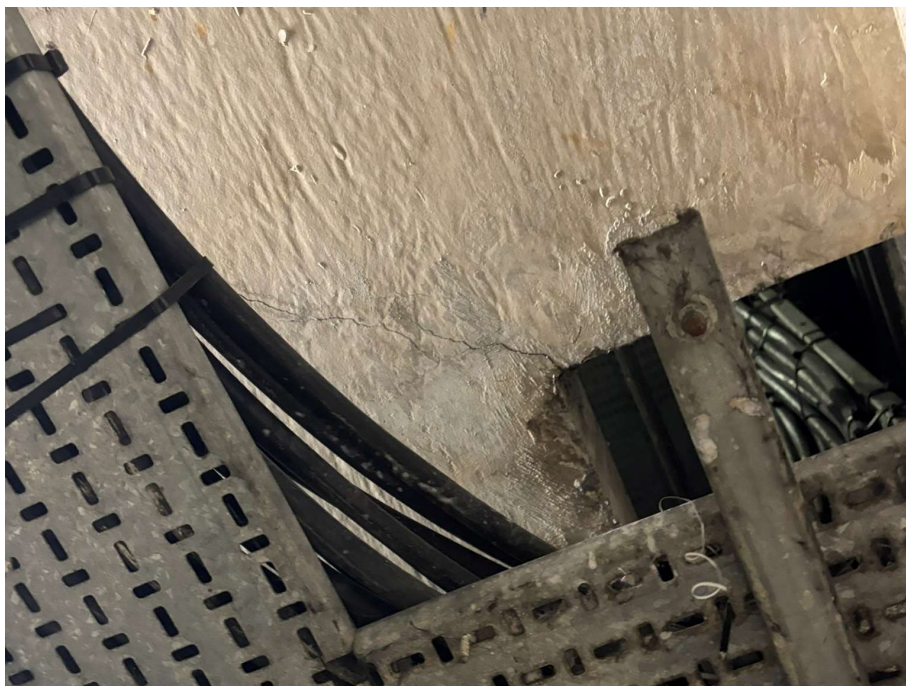
*Figure 31 - Typical photograph of cracking to concrete basement slab at service penetration corner*

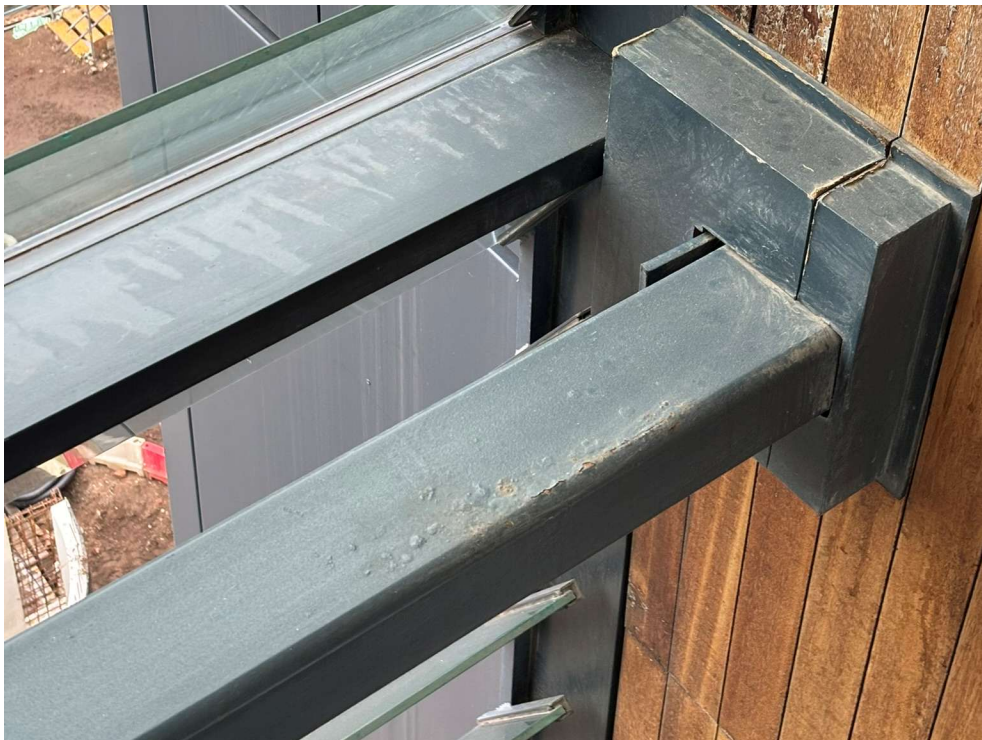
*Photograph 2 - Typical Photograph of Surface Corrosion to Gridline C*

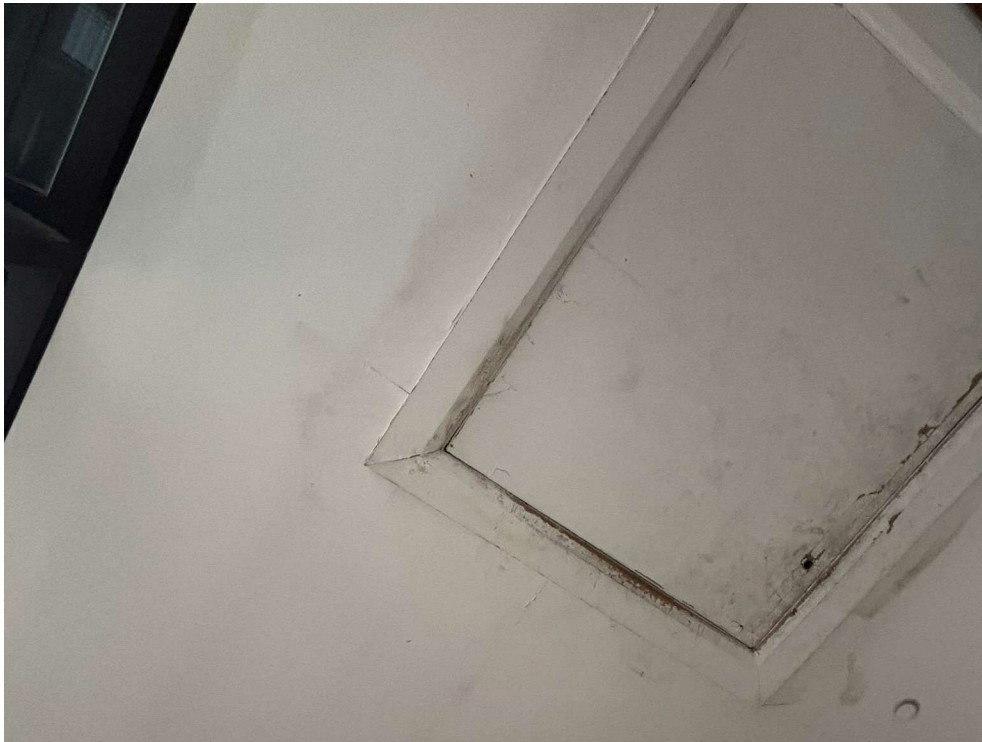
*Photograph 3 - Typical Photograph of Water Ingress*

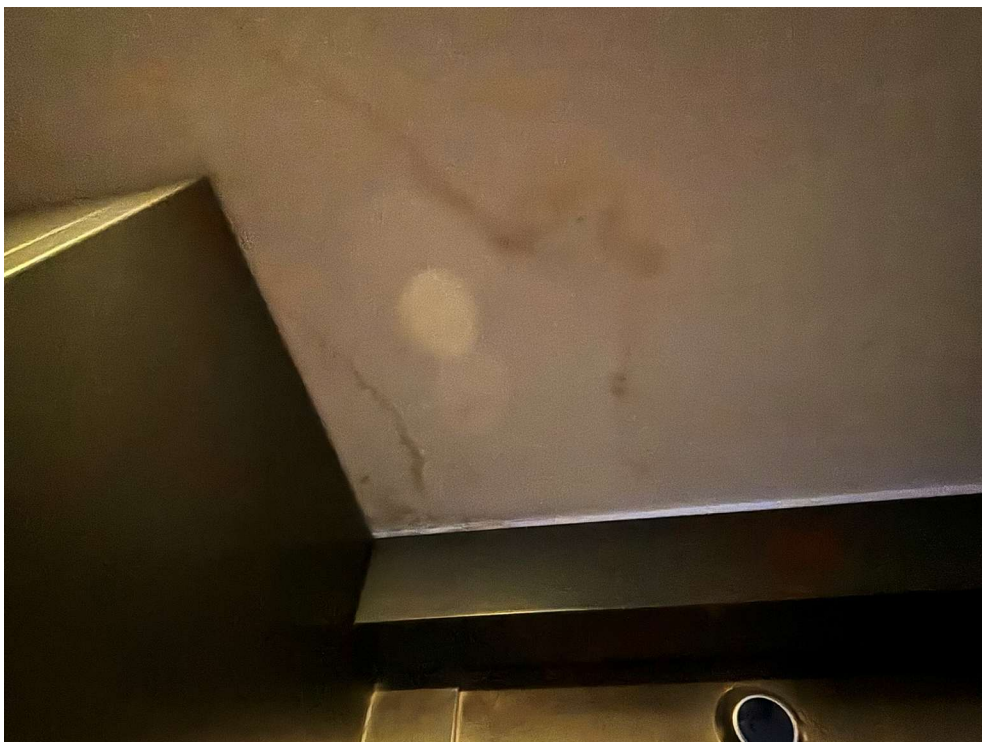
*Photograph 4 - Typical Photograph of Water Ingress*

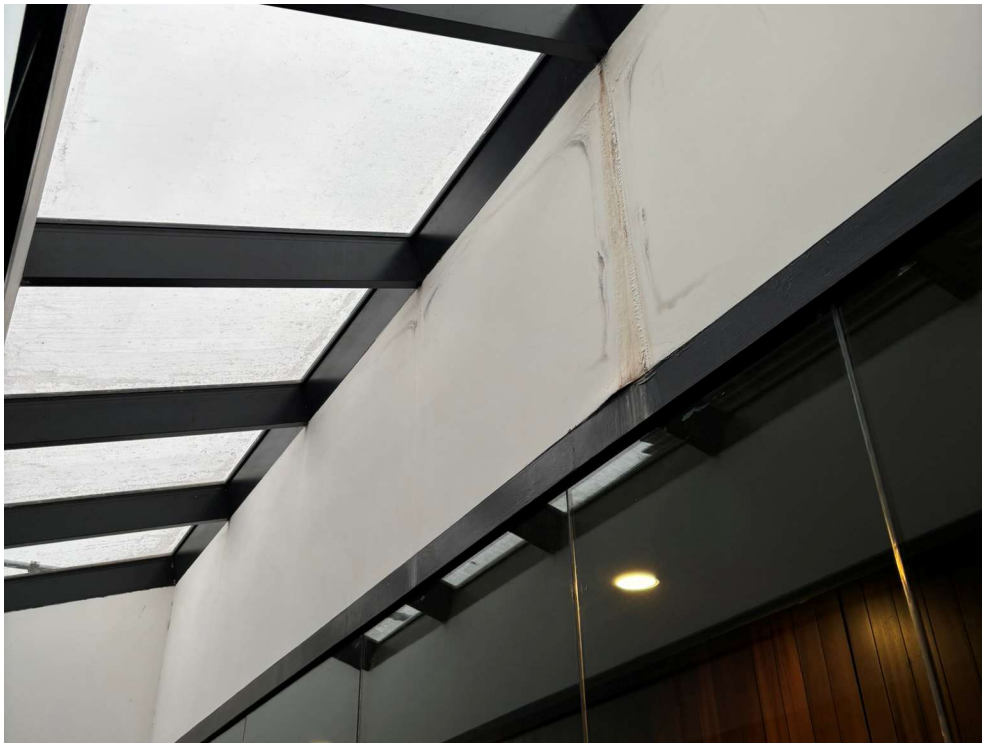
*Photograph 5 - Typical Photograph of Water Ingress*

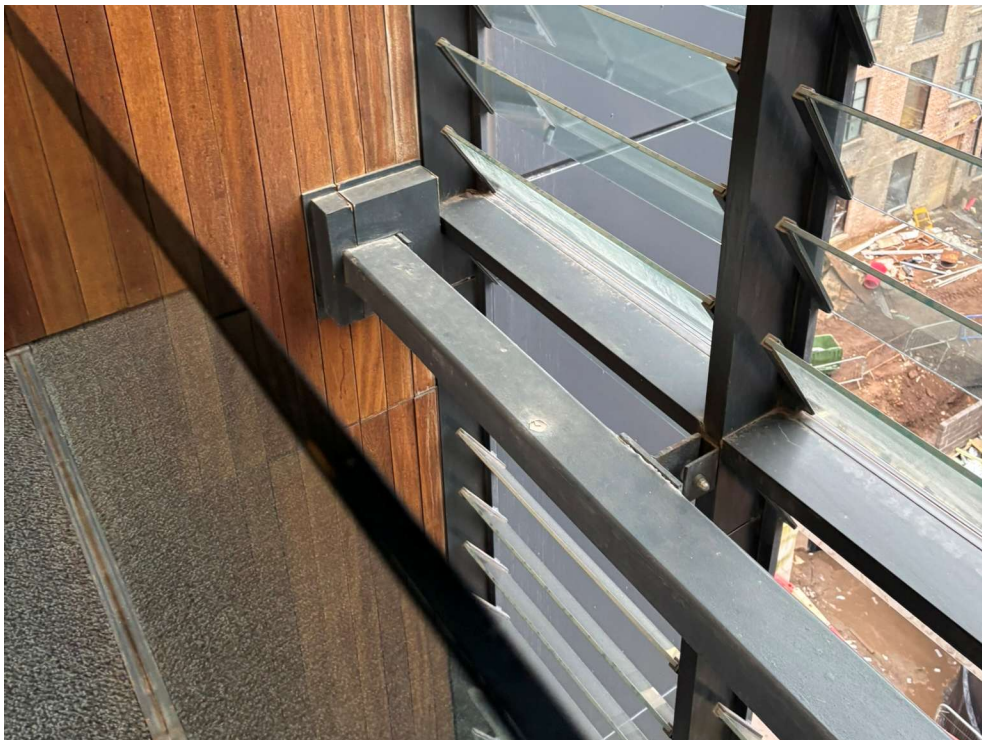
*Photograph 6 - Typical Photograph of Surface Corrosion to Gridline C*

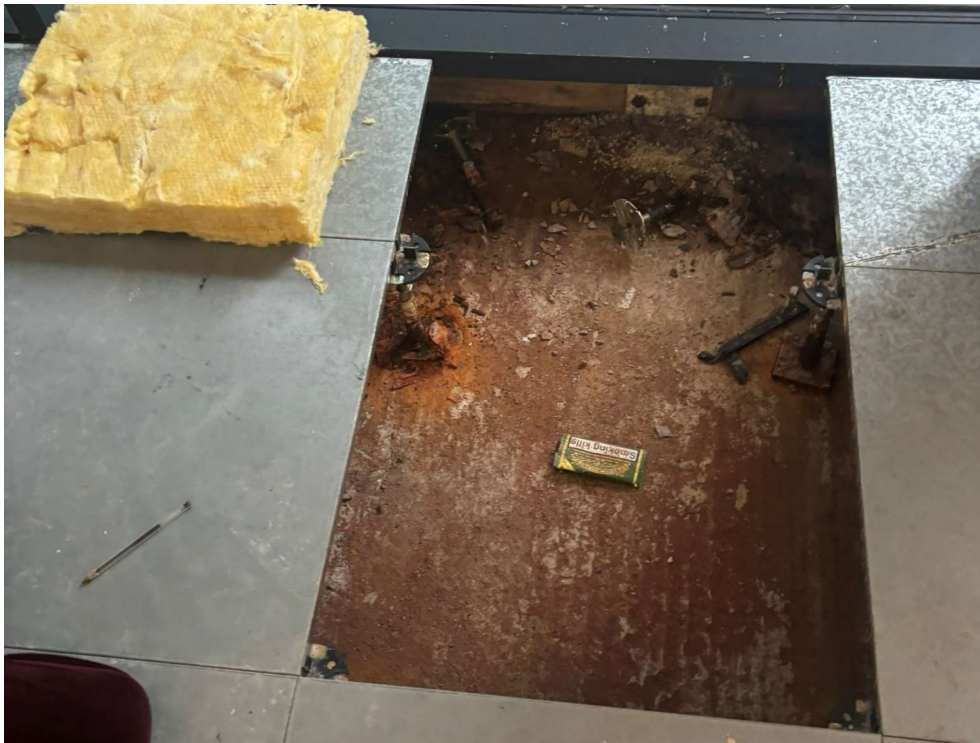
*Photograph 7 - Water Ingress Within The Ground Floor*

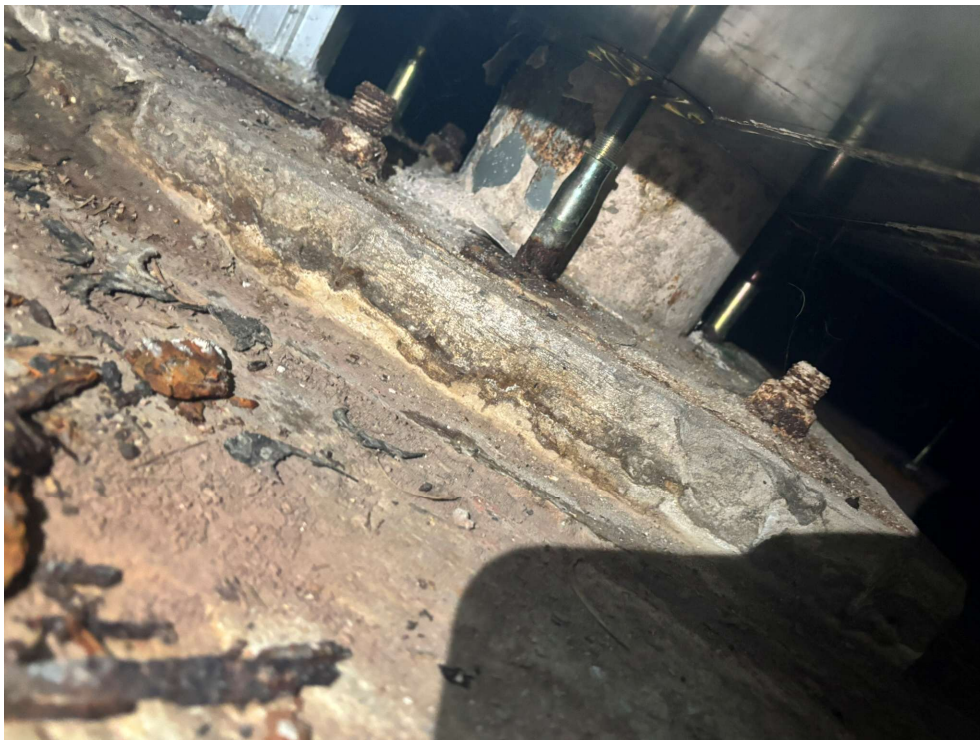
*Photograph 8 - Corrosion To Column Base Plate*

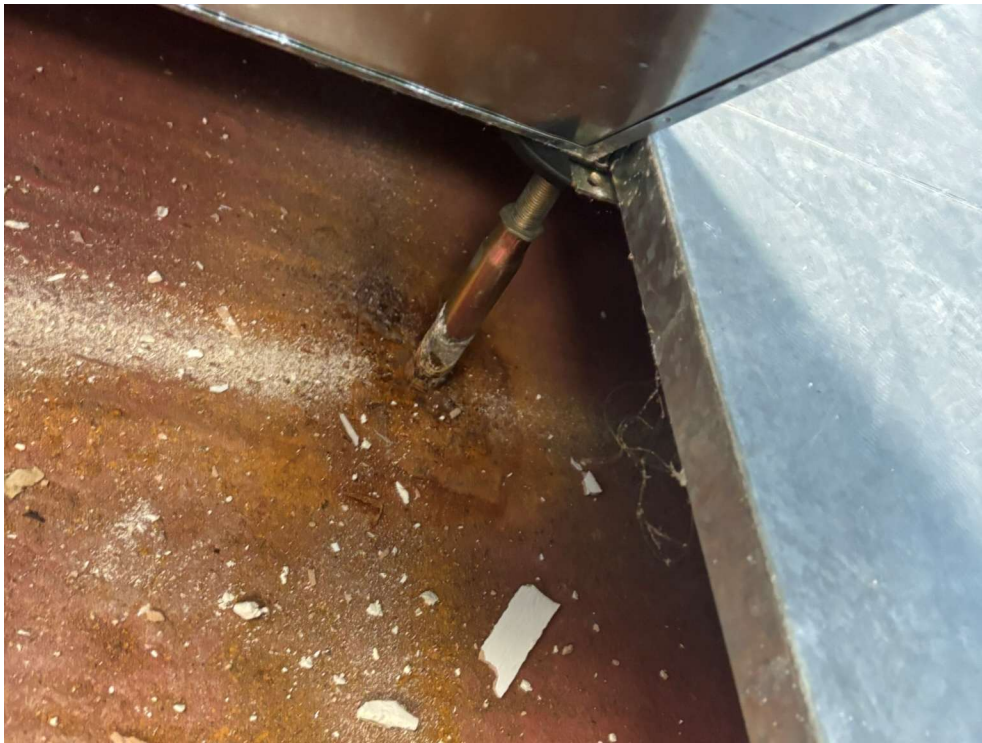
*Photograph 9 - Corrosion To The Raised Access Floor Leg Supports*

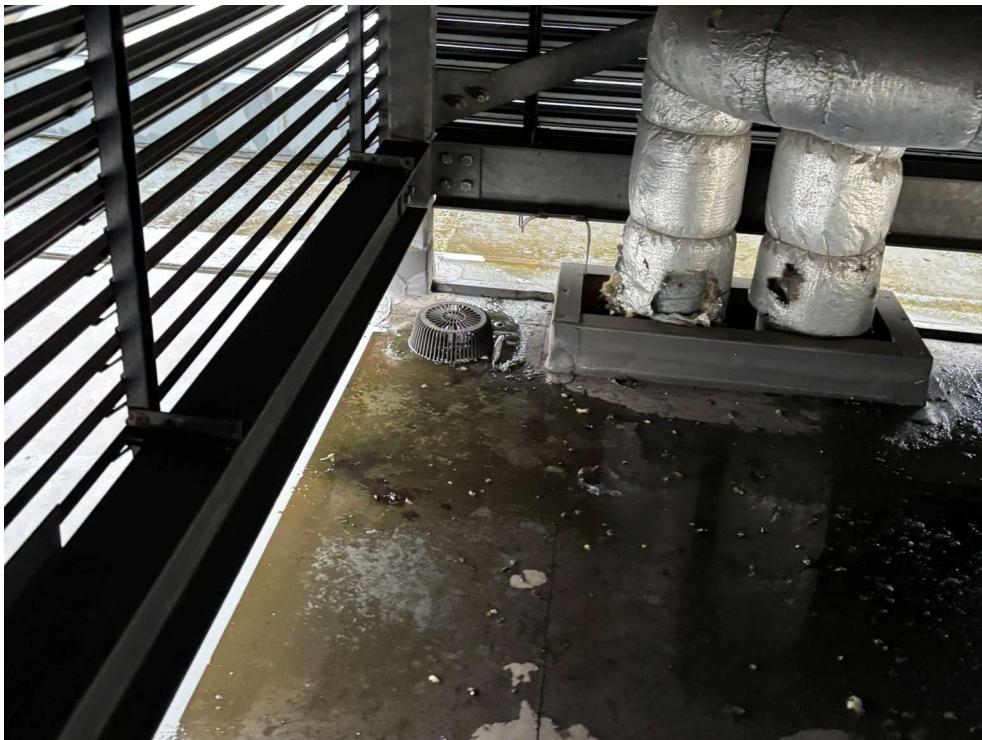
*Photograph 10 - Ponding Water At Roof Level*

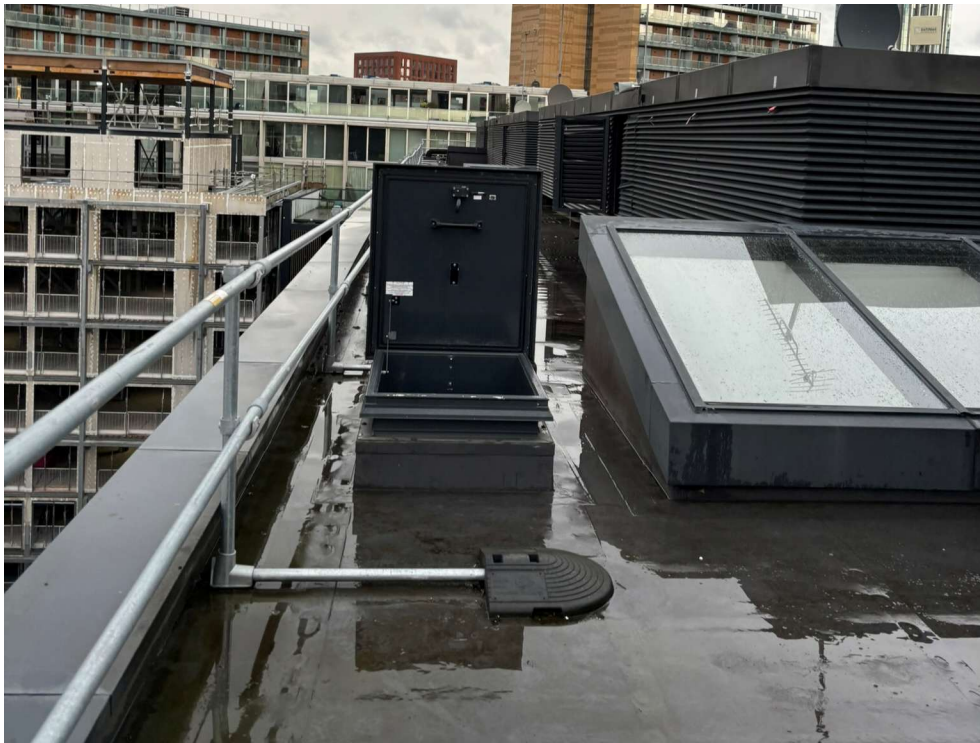
*Photograph 11 - Ponding Water At Roof Level*

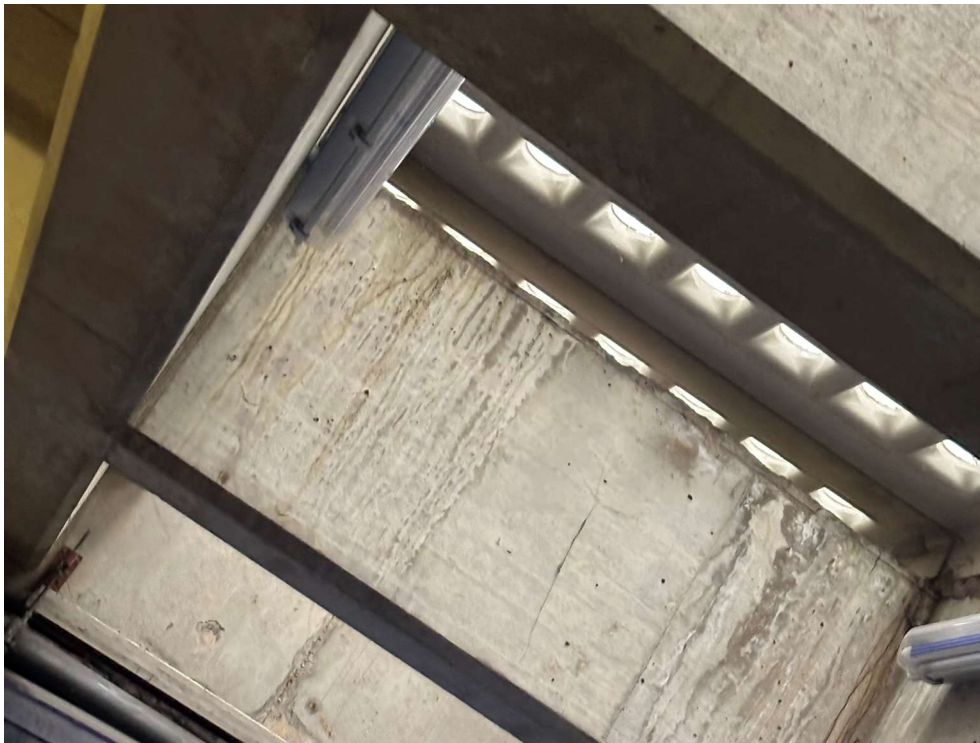
*Photograph 13 - Water Ingress Within Basement Areas External to the Main Building Footprint at the Transition Between In-Situ Deck and Natural Light Floor Construction.*

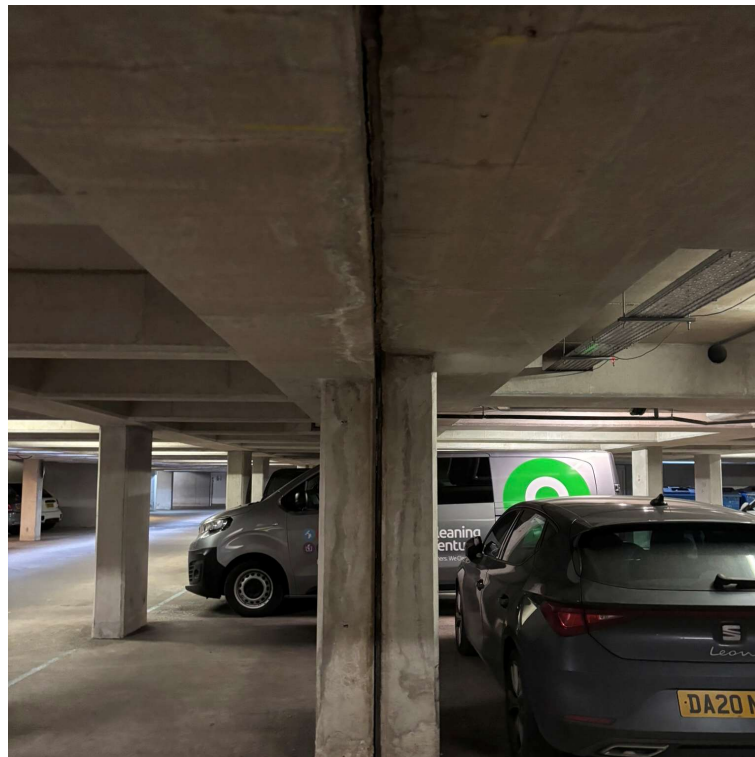
*Photograph 14 - Failed movement joint between Burton Place and MOHO with voids allowing water ingress*

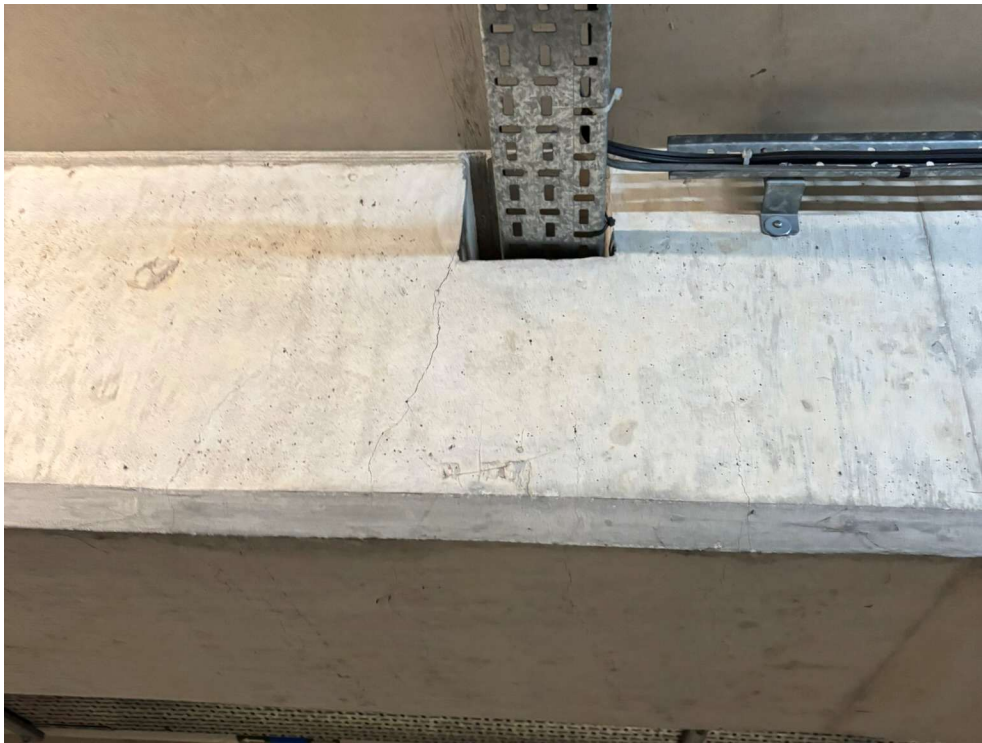
*Photograph 15 - Hairline Cracking To Basement Concrete Beams Local To Service Penetrations*

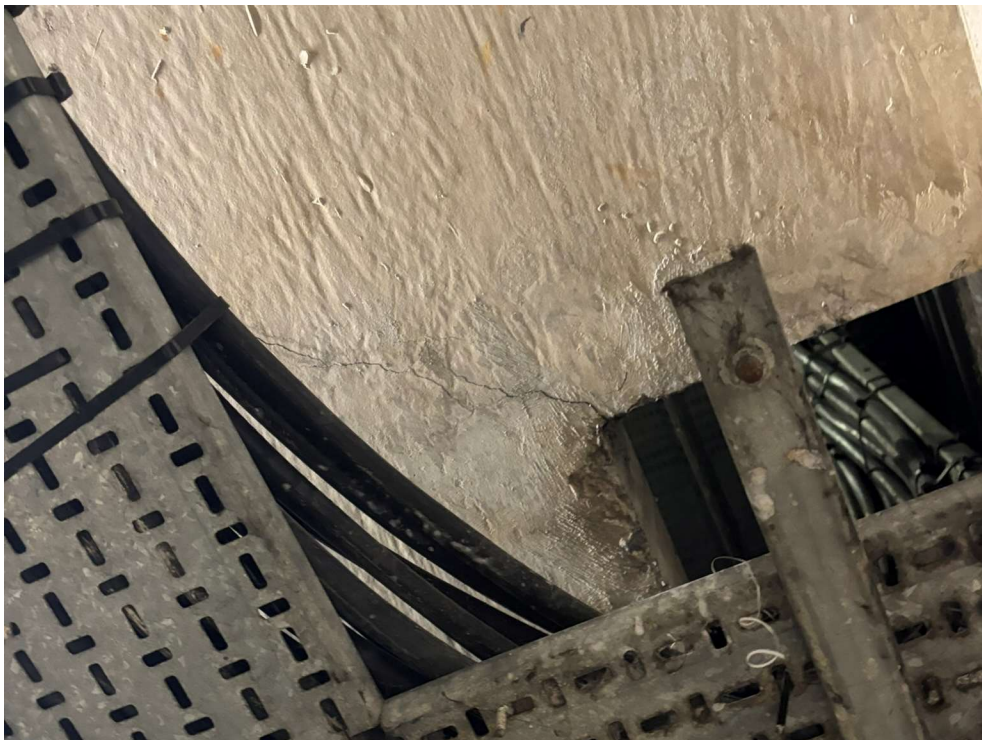
*Photograph 16 - Hairline Shrinkage Cracking To Soffit Of In-Situ Reinforced Concrete Basement Floor Plate*

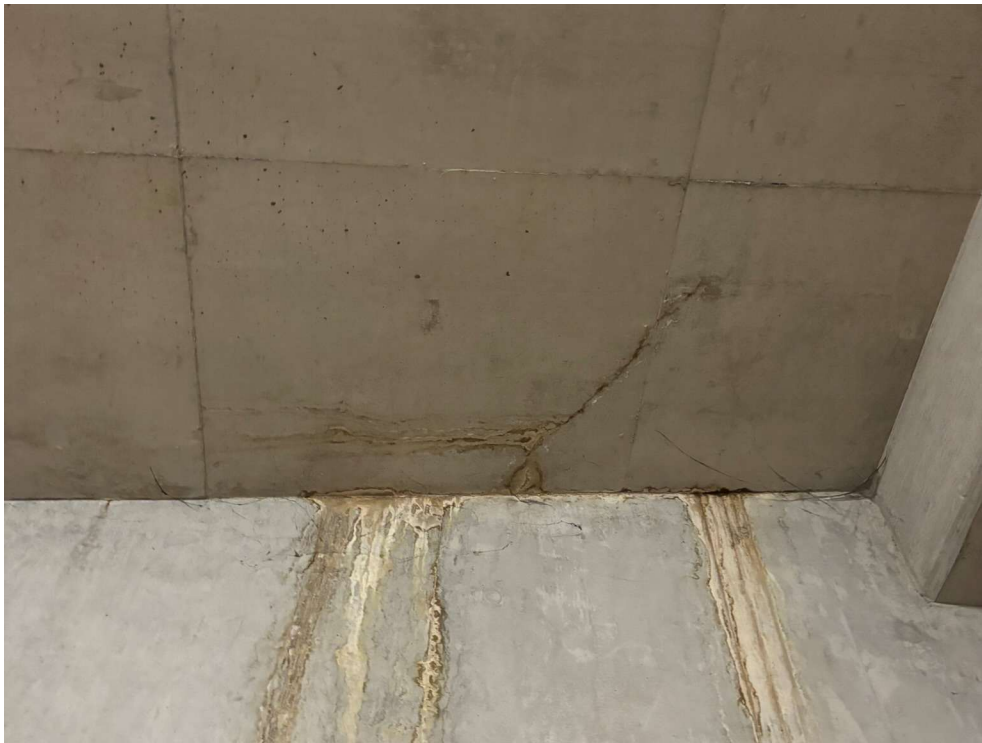
Photograph 17 - Hairline Shrinkage Cracking To Soffit Of In-Situ Reinforced Concrete Basement Floor Plate

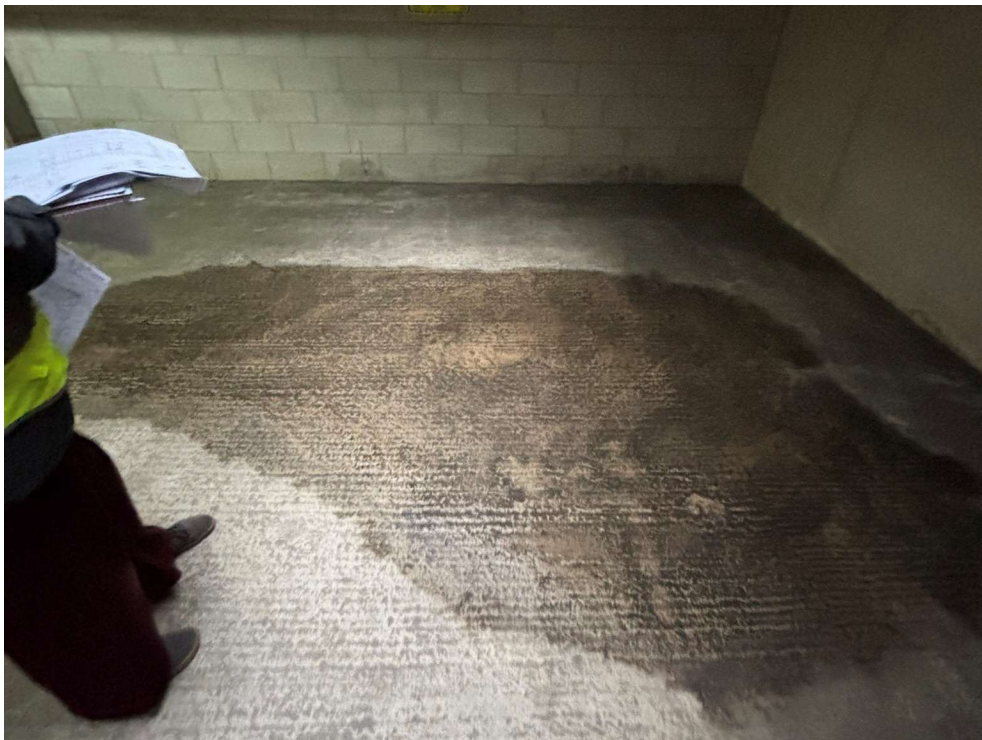
Photograph 18 - Water Ponding - Basement Level 1 Between Gridline J and 1
