**Burton Place Apartments**

**252780-CCS-S1-XX-RP-S-0002**

**BWP Consultant**

## Structural Investigation Report

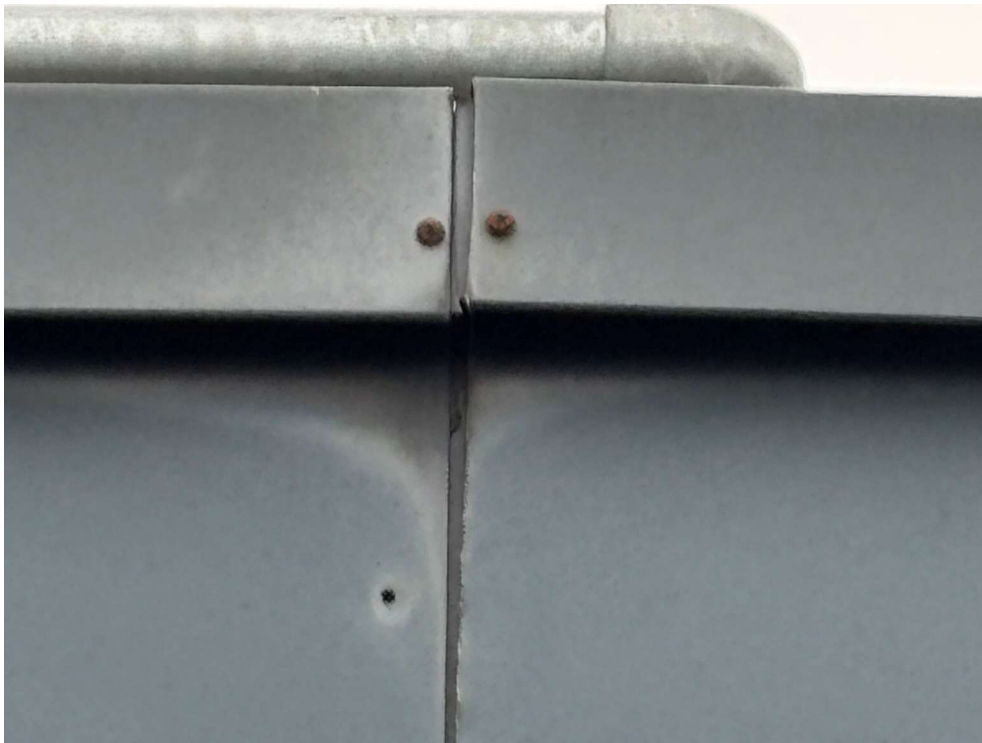
*Photograph 19 - Missing Fixings To Cladding At Roof Level Gridline D*

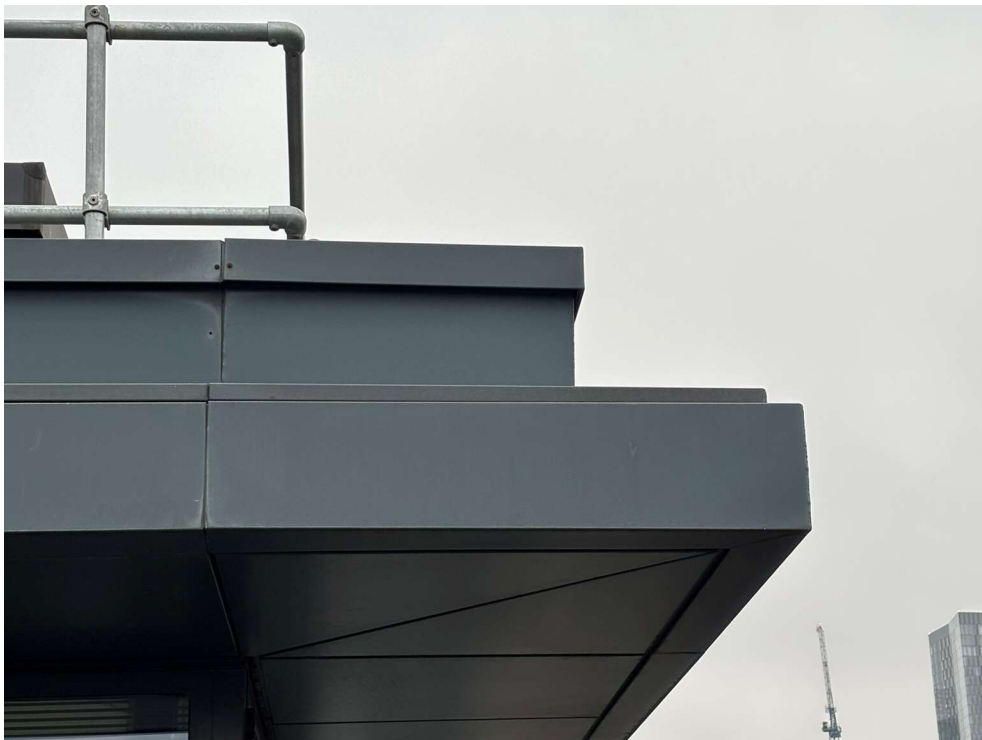
*Photograph 20 – Deflection to Roof Gridline 15*

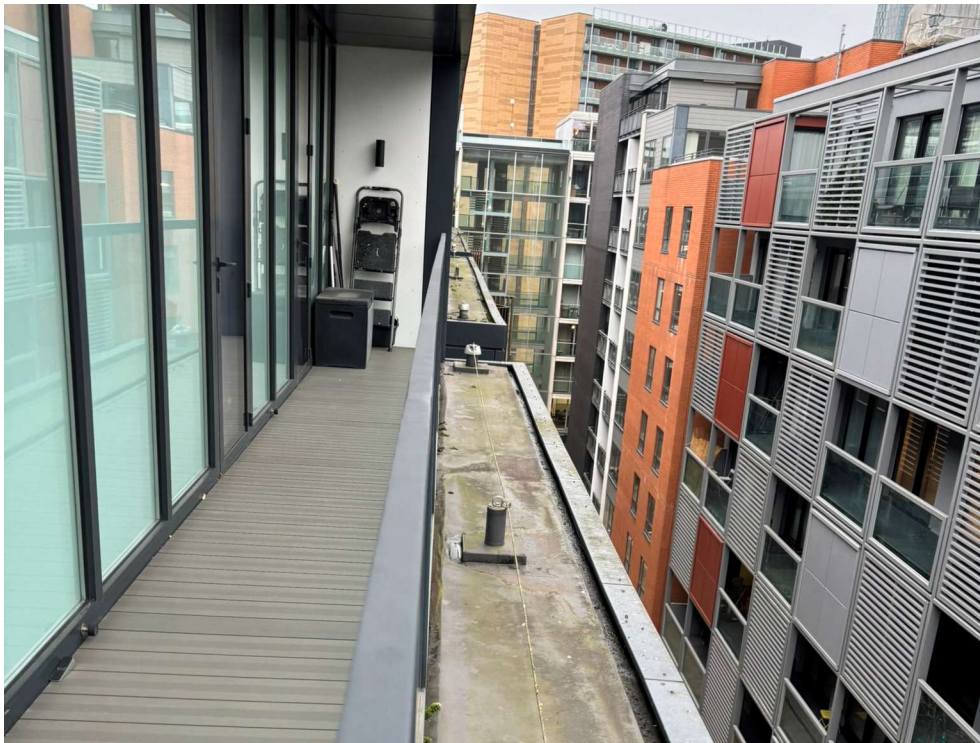
*Photograph 21 – Moss Growth to Roof Finish at Level 7*
