Health, Safety & Fire Risk Assessment

Timber Wharf Management Limited

**Timber Wharf
Worsley Street
Castlefield
Manchester
M15 4NZ**

Report reference No: HSF68343/0039/110326/4

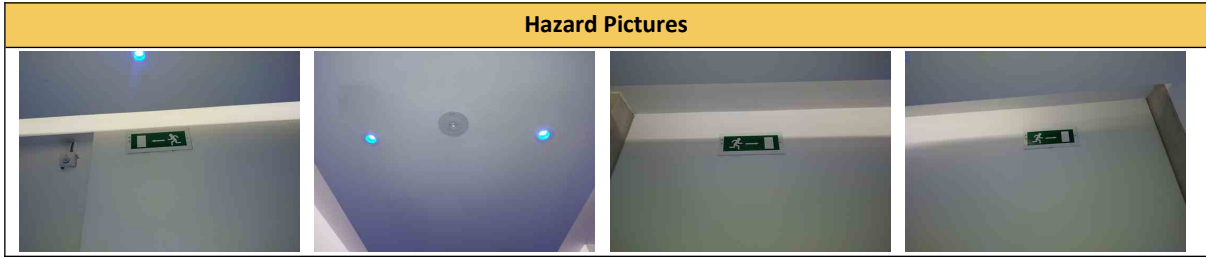
Emergency light inoperative i.e. LED not armed. Potential to cause serious injury and to hinder an evacuation from the building in the event of an emergency situation or failure of the main electrical power supply.				
People at Risk				
Employees/Contractors/Visitors/Public/Tenants				
Hazard Evaluation				
Severity:	Likelihood/Frequency:	Risk Rating:	Priority:	
4	1	4	2	
Useful Legislation and Guidance				
The Regulatory Reform (Fire Safety) Order 2005. Management of Health & Safety at Work Regulations 1999. BS5266-1:2025 Emergency Lighting

Action Required and Further Control Measure				
Employ a qualified, competent and 3rd party accredited contractor to repair / replace the emergency light unit. Ensure that the emergency lighting system is included on the building's maintenance schedule.				
Action Carried Out By:			Action Taken:	
Date:

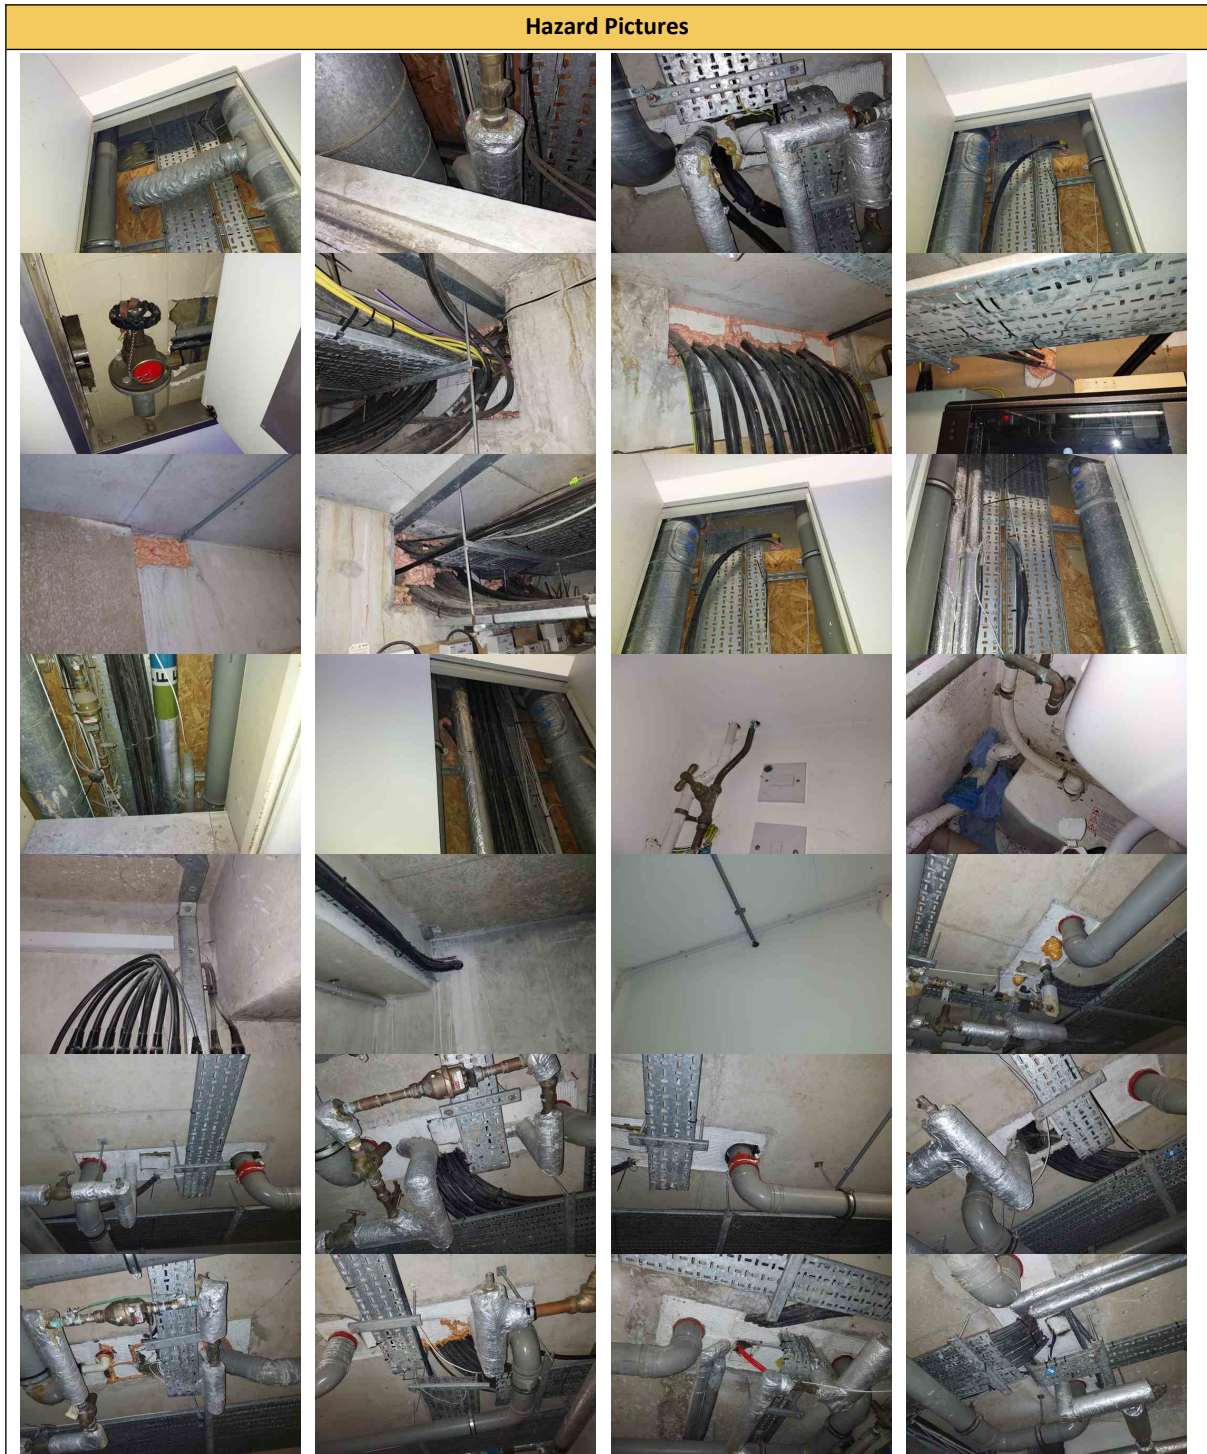
Whilst a compartmentation survey has been completed, it appears the remedial actions identified within haven't been actioned.			
People at Risk			
Employees/Contractors/Visitors/Public/Tenants			
Hazard Evaluation			
Severity:	Likelihood/Frequency:	Risk Rating:	Priority:
4	2	8	2
Useful Legislation and Guidance			
The Regulatory Reform (Fire Safety) Order 2005 The Association of Specialist Fire Protection Technical Guidance Document TGD 17			
Action Required and Further Control Measure			
Employ a qualified and competent third party contractor to undertake the remedial works identified within the compartmentation survey. Fire stopping works should be subject to regular inspections (no longer than annual) to monitor condition with suitable records maintained.

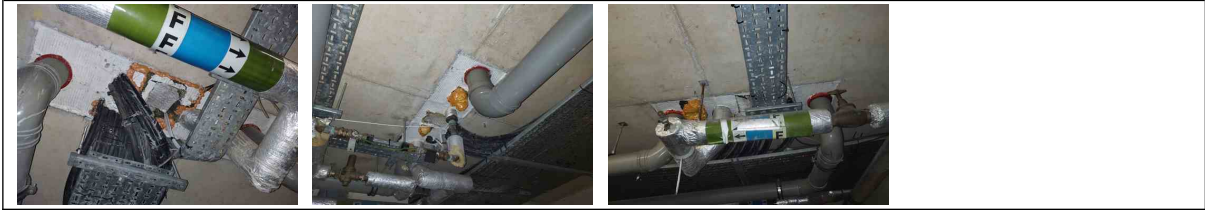
3.4 Action Plan – Fire Risk/Hazards Risk/Hazard				
Site Address	Timber Wharf Worsley Street Castlefield Manchester M15 4NZ	Risk No/Type	FCOMP05	Fire
		Assessor	Andrew Thompson MIIRSM, MIFSM	
		Date	11/03/2026	
		Responsible Person/ Body	Timber Wharf Management Limited	
Hazard Location				
Ceiling basement 1				
Hazard Description

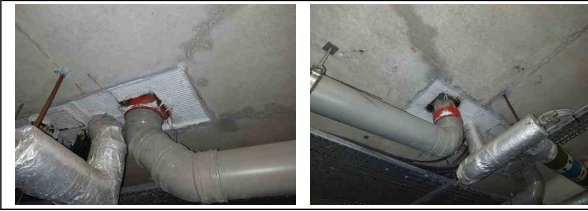
3.4 Action Plan – Fire Risk/Hazards Risk/Hazard				
Site Address	Timber Wharf Worsley Street Castlefield Manchester M15 4NZ	Risk No/Type	FCOMP08	Fire
		Assessor	Andrew Thompson MIIRSM, MIFSM	
		Date	11/03/2026	
		Responsible Person/ Body	Timber Wharf Management Limited

Action Required and Further Control Measure				
To maintain suitable compartmentation where plastic pipes pass through the ceiling / floor levels, employ a competent and third party contractor to repair / replace intumescent pipe collar to the side where it passes through. Fire stopping works should be subject to regular inspections (no longer than annual) to monitor condition with suitable records maintained.				
<table border="0" style="width: 100%;"> <tr> <td style="width: 50%;">Action Carried Out By:</td> <td style="width: 50%;">Action Taken:</td> </tr> <tr> <td>Date:</td> <td></td> </tr> </table>	Action Carried Out By:	Action Taken:	Date:	
Action Carried Out By:	Action Taken:			
Date:

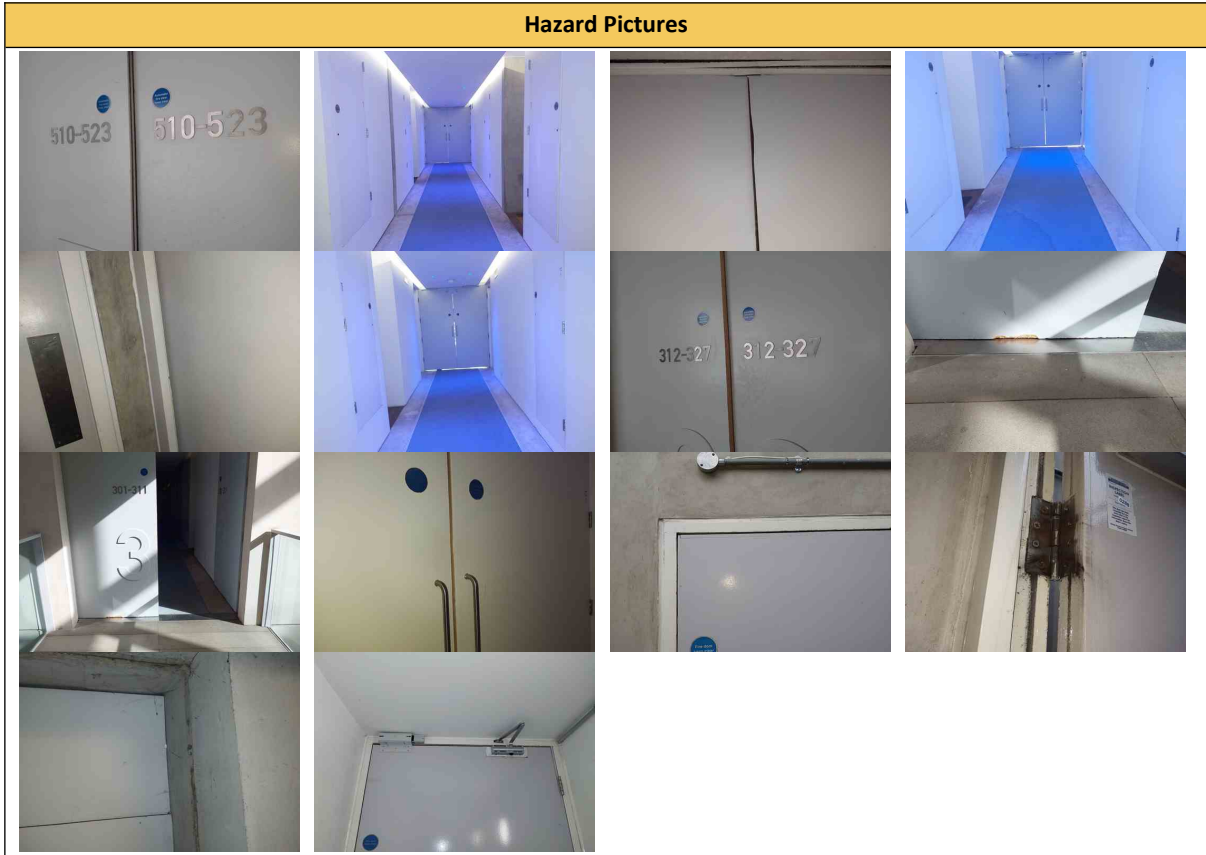
3.4 Action Plan – Fire Risk/Hazards Risk/Hazard				
Site Address	Timber Wharf Worsley Street Castlefield Manchester M15 4NZ	Risk No/Type	FD02c	Fire
		Assessor	Andrew Thompson MIIRSM, MIFSM	
		Date	11/03/2026	
		Responsible Person/ Body	Timber Wharf Management Limited	
Hazard Location				
Corridor doors				
Hazard Description

People at Risk				
Employees/Contractors/Visitors/Public/Tenants				
Hazard Evaluation				
Severity:	Likelihood/Frequency:	Risk Rating:	Priority:	
4	2	8	2	
Useful Legislation and Guidance				
The Regulatory Reform (Fire Safety) Order 2005. The Fire safety (England) Regulations 2022. BS 476, BS EN 1634.				
Action Required and Further Control Measure

Employ a qualified, competent and 3rd party accredited contractor to undertake the remedial works to the doors as highlighted within the fire door survey with additional surveys implemented on a quarterly basis (refer to non-compliance 4.2.74b)				
Action Carried Out By:			Action Taken:	
Date:

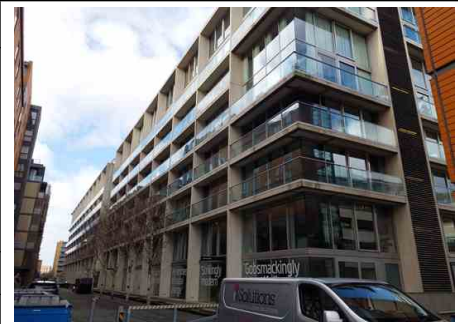
3.4 Action Plan – Fire Risk/Hazards Risk/Hazard				
Site Address	Timber Wharf Worsley Street Castlefield Manchester M15 4NZ	Risk No/Type	MMRC06	H&S
		Assessor	Andrew Thompson MIIRSM, MIFSM	
		Date	11/03/2026	
		Responsible Person/ Body	Timber Wharf Management Limited	
Hazard Location				
Throughout property				
Hazard Description				
Flat entrance doors. Pending the remediation of compartmentation as a result of the non fire rated materials used, there is an increased risk of internal fire spread.				
People at Risk				
Disabled/visitors/contractors/tenants on site				
Hazard Evaluation				
Severity:	Likelihood/Frequency:	Risk Rating:	Priority:	
4	2	8	2	
Useful Legislation and Guidance				
Building Regulations Approved Document B4. Regulatory Reform (Fire Safety) Order 2005. Fire Safety Act 2021. NFCC Guidance Note 4th Edition August 2022.				
Action Required and Further Control Measure				
Employ a qualified, competent and 3rd party accredited contractor to inspect all flat entrance doors ensuring that letter boxes (where installed) are 30 minute fire rated, and that doors that open onto escape routes and stairwells are fire-resisting and have effective self-closing devices installed, overcoming any latch.

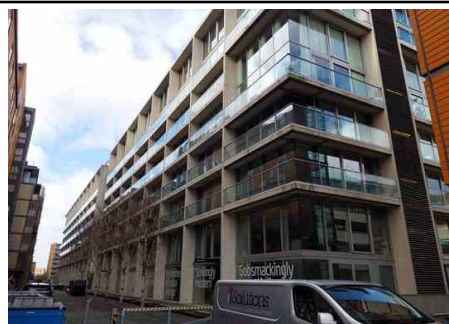
3.4 Action Plan – Fire Risk/Hazards Risk/Hazard				
Site Address	Timber Wharf Worsley Street Castlefield Manchester M15 4NZ	Risk No/Type	MMRC09	H&S
		Assessor	Andrew Thompson MIIRSM, MIFSM	
		Date	11/03/2026	
		Responsible Person/ Body	Timber Wharf Management Limited	
Hazard Location				
Throughout property				
Hazard Description				
Fire fighting facilities. Pending the remediation of compartmentation as a result of the non fire rated materials used, there is an increased risk of internal fire spread.				
People at Risk				
Disabled/visitors/contractors/tenants on site				
Hazard Evaluation				
Severity:	Likelihood/Frequency:	Risk Rating:	Priority:	
4	2	8	2	
Useful Legislation and Guidance				
Building Regulations Approved Document B4. Regulatory Reform (Fire Safety) Order 2005. Fire Safety Act 2021. NFCC Guidance Note 4th Edition August 2022.				
Action Required and Further Control Measure				
Employ a qualified, competent and 3rd party accredited contractor to inspect all facilities that are provided for fire fighters, including fire fighting lifts, dry rising mains and fire hydrants.

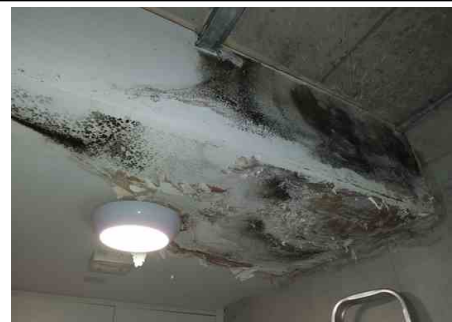
3.5 Action Plan – Fire Risk/Hazards Risk/Hazard				
Site Address	Timber Wharf Worsley Street Castlefield Manchester M15 4NZ	Risk No/Type	W10a	H&S
		Assessor	Andrew Thompson MIIRSM, MIFSM	
		Date	11/03/2026	
		Responsible Person/ Body	Timber Wharf Management Limited	
Hazard Location				
Basemen1 kitchen/toilet area				
Hazard Description				
Evidence of Water Ingress/Leak, and black mould. Potential for localised flooding, damage to building structure, and health issues associated with damp conditions.				
People at Risk				
Employees/Contractors/Visitors/Public/Tenants				
Hazard Evaluation				
Severity:	Likelihood/Frequency:	Risk Rating:	Priority:	
1	1	1	3	
Useful Legislation and Guidance				
Health & Safety at Work Act 1974. Management of Health & Safety at Work Regulations 1999.Workplace (Health, Safety & Welfare) Regulations 1992,				
Action Required and Further Control Measure				
Employ a qualified, competent and 3rd party accredited contractor to investigate the source of the leak and carry out any necessary repairs. Ensure area is inspected regularly as part of the building maintenance schedule to check for any recurrence.
