**Burton Place Apartments**

**252780-CCS-S1-XX-RP-S-0002**

**BWP Consultant**

## Structural Investigation Report

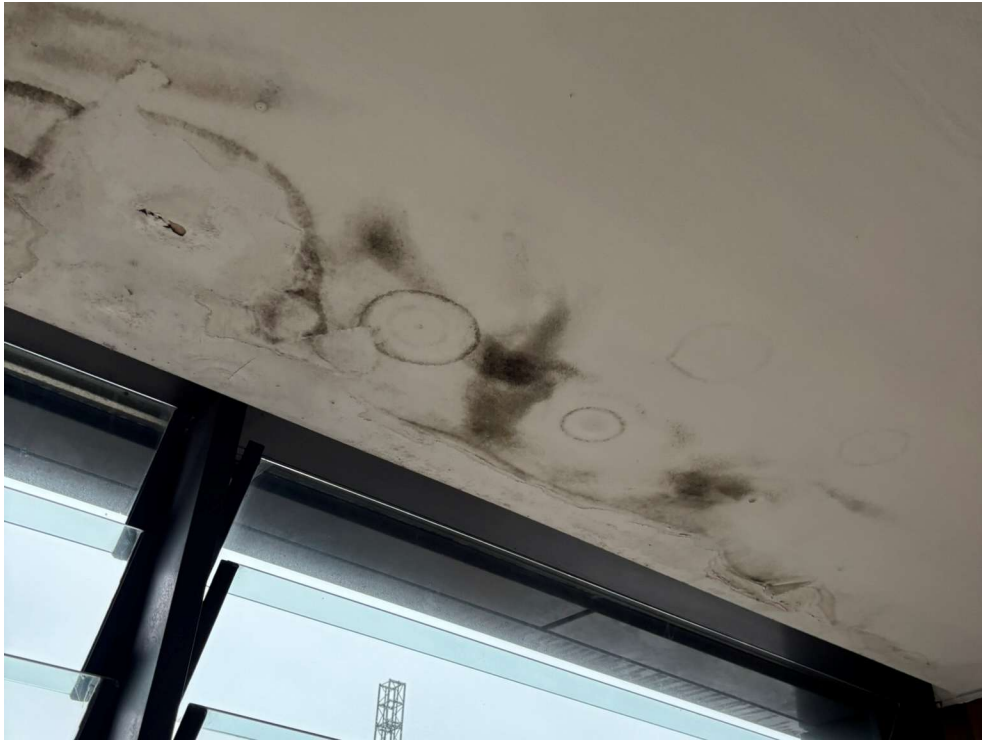
*Photograph 1 - Typical Photograph of Water Ingress*
