**Burton Place Apartments**

**252780-CCS-S1-XX-RP-S-0002**

**BWP Consultant**

## Structural Investigation Report

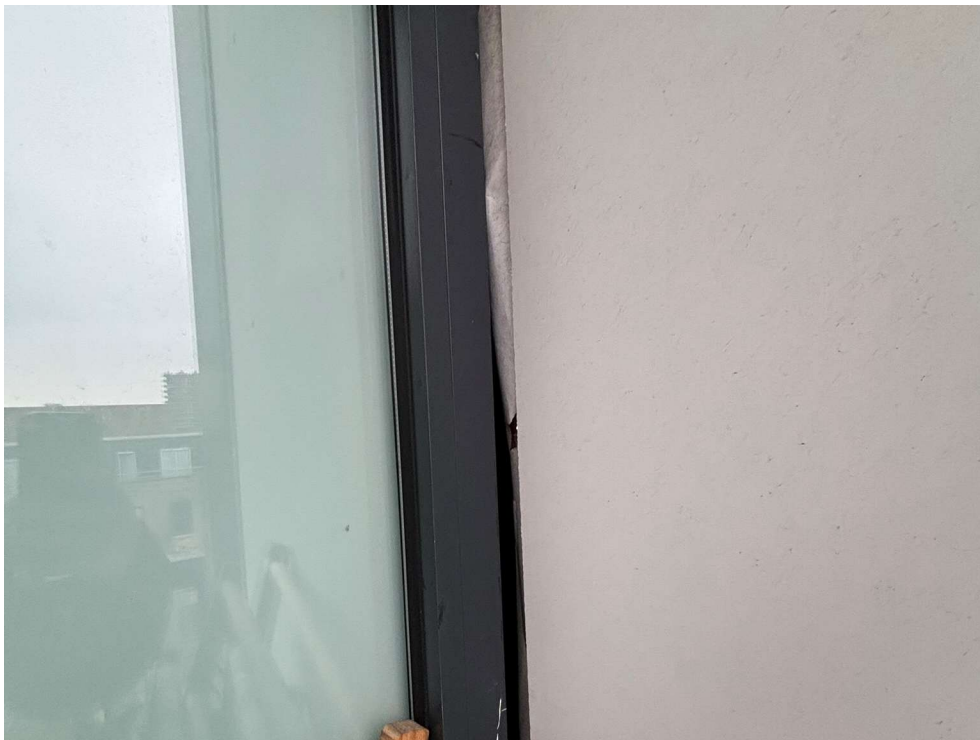
*Photograph 22 - Gap Between External Finishes Level 6 Gridline 7D*
